Drive shaft as removed with low spd shudder

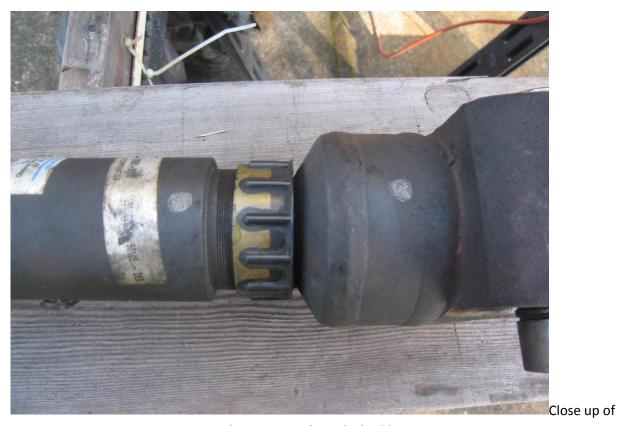
alignment marks with shudder

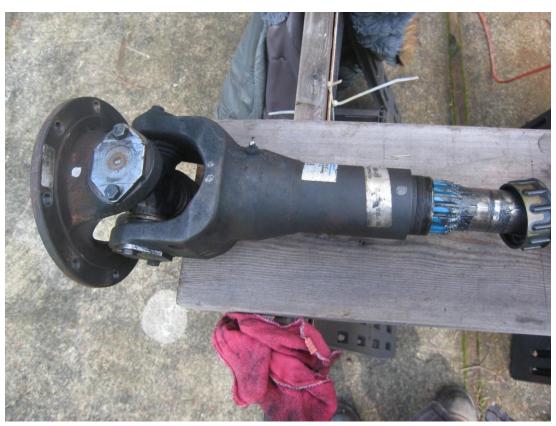
Slip joint seal pulled back from spline joint

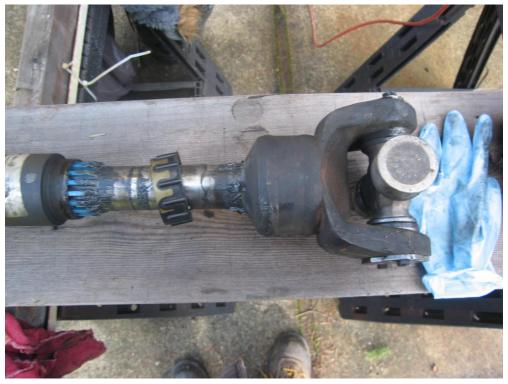
Fwd section DS rotated 90 deg away (note absence match mark out of view toward top)
