| TSB140030 |

ISX15 and QSX15 Early Life Oil Consumption Caused by Vertical Liner Lobing

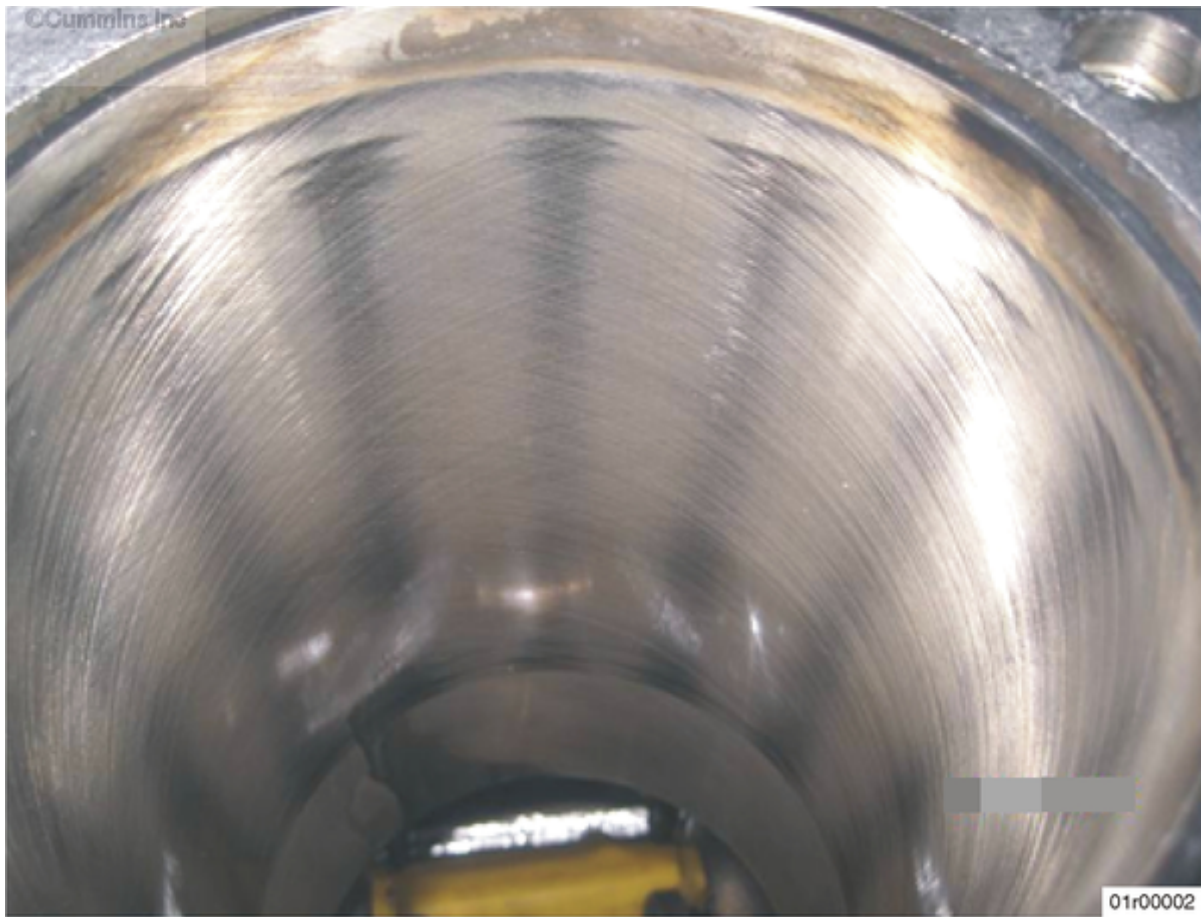
Figure 1: Cylinder Liner with Obvious Evidence of Lobing

Suspect used liners may show visual evidence of the 13 equally spaced vertical lobing pattern, as seen in Figures 1 and 2.

Figure 1 is a worst-case example that shows a cylinder liner at 33,000 miles and 635 Miles per Quart (MPQ) oil consumption. Carbon packing has started on all pistons but bore polish in all liners has **not** become an issue yet.

Lobed liners are considered non-reusable and need to be replaced. If this lobing pattern is identified, inspect all six cylinders and replace cylinder liners as necessary.

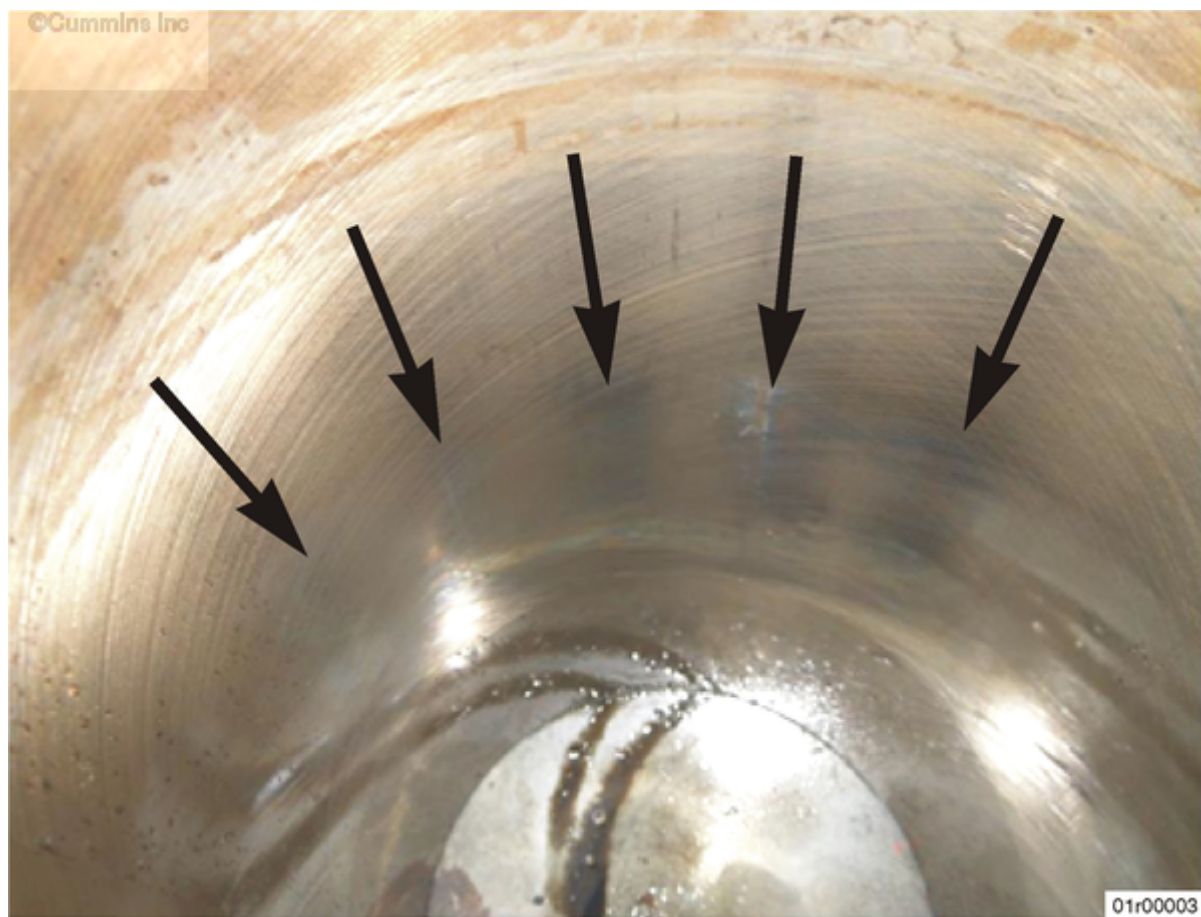
Figure 2: Cylinder Liner with Subtle Evidence of Lobing

Figure 2 shows a mild case of liner lobing that can be challenging to identify visually. This engine had 119,000 miles and an oil consumption complaint of 460 Miles per Quart (MPQ). It also experienced carbon packing on all pistons, which resulted in bore polish in the other liners. This is an example of an engine that likely had a small, unnoticed oil consumption issue early in life, but was **not** identified by the customer until the resulting carbon packing polished the liners.

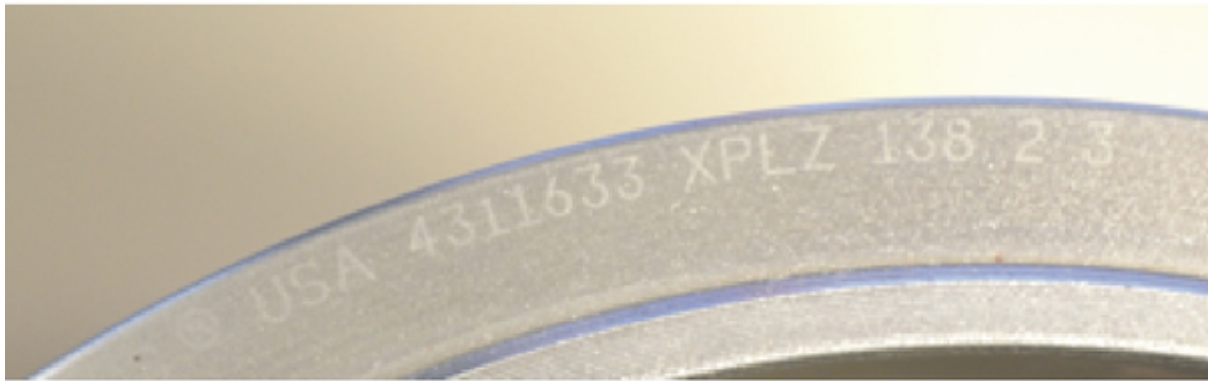
01r00004

Figure 3: (Photograph for reference only.) The date code in the photograph above is suspect for liner lobing and would require inspection. The date code is formatted as Day, Year, and Shift. "138 2 3" translates to the 138th day of the year, the year 2012, and the third shift of the day or May 18th, 2012, Third Shift.

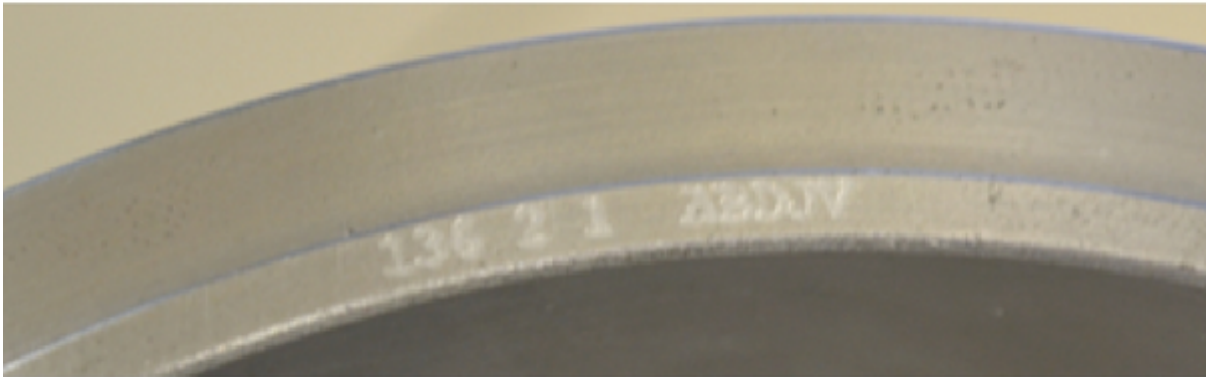
01r00005

Figure 4: (Photograph for reference only.) The photograph above shows the ABDJV marking. This liner would not be suspect for liner lobing because of the ABDJV marking.
