# Steering Bracket Reinforcement

## Alpine Coaches, 2004-2009 Model Years

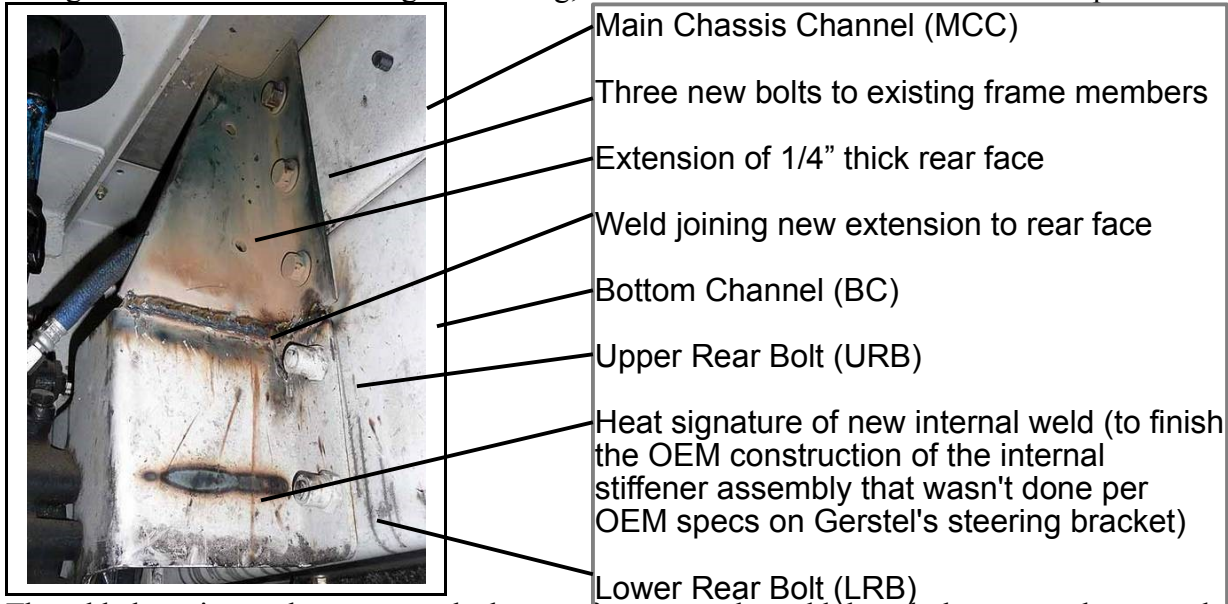
On Dale Gerstel's 40' 2007 coach (photo below is Dale's SB), the bending had caused a stress crack downward, more or less along the bend between the rear bolt flange and the rear face of the SB. This was from a combination of prying action on the flange and torsional bending of the SB box. The crack was a serious structural issue and may have become a safety hazard over time. Dale's bracket might have seen more bending than properly welded brackets, remembering that it was missing some internal welds that are part of the factory SB design. However, a similar non-internally-welded SB observed at DRR8 behaved visually about the same as other properly welded SB's.

The added portion at the top extends the rear face upward to add three bolts, one at the upper level of the BC, and two in the MCC. This ties the BC & MCC together with a stiffener (the enlarged rear face), addressing the “thin plate” issue of the BC. It also ties the rear face, with three new fastening points, to more of the frame to arrest up-down torsion. Insofar as it uses a longer rear face/flange section, it also improves resistance to prying action on the URB & LRB.

Using a combination of welding and bolting, Dale reinforced his SB as shown in the photo below.

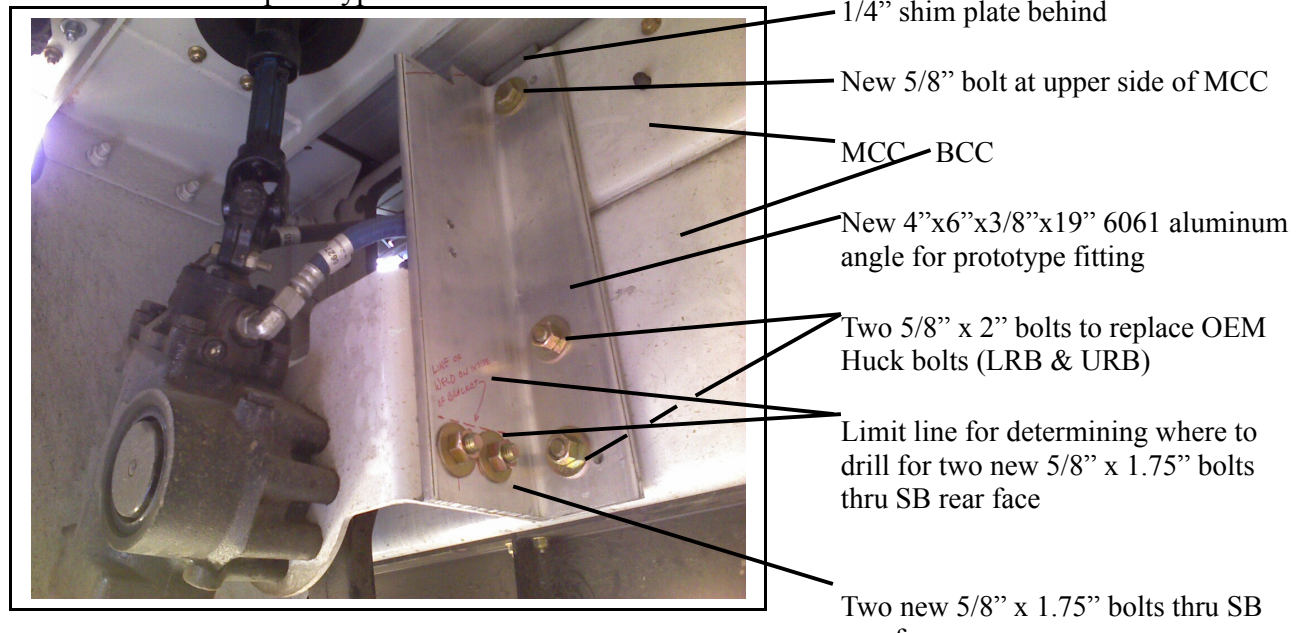
There are several reasons contributing to the significant deflection (bending) of the OEM SB. First, it bends up & down at the rear face, in a torsional deflection of the SB “box,” because the steel (1/4”) and the internal reinforcing plates are too thin to fully resist this torsional force. Second, the upper rear bolt, fastening the bracket to the BC at about mid-height of its channel, deflects in and out (left to right on the coach centerline) because the tall BC is a “thin plate” and the mid-height section is a long way structurally speaking to the reinforcing edges (flanges) of the channel. The BC can therefore warp from a flat plane channel. The MCC by contrast, is much more compact so the mid-height section is much closer to its reinforcing “flanges.” Third, the SB box deflects fore-aft due to its thin plates. Finally, the rear flange is subject to prying action that deflects the flange toward & away from the BC.

Here is the author's prototype SBB solution:

The above method buttresses the factory design by providing:

- 1) a thick, large, flat pressure plate mashing the rear bolt flange to the chassis frame members under the oversized Grade 8 washers. The Huck bolts are replaced with 5/8" Grade 8 fine thread bolts torqued to approximate the slip-critical Huck bolt fastening which is important if anyone is going to remove the Huck bolts. The large hold-down-plate will add resistance to prying action on the rear flange.

- 2) added stiffness of the new angle to the rear-face/rear-flange fold in the SB plate steel. This will add resistance to out-of-plane bending of the rear face (fore-aft) that contributes to prying action on the original Huck bolts.

- 3) a long and therefore torque resistant, thick and therefore stiff, extension to the rear-face/rear-flange portion of the assembly
- 4) a remote and therefore torque resistant fastener into the upper portion of the MCC. This combined with the two bolts into the rear SB face will better resist in-plane torquing of the rear face.

- 5) a long plate/angle spanning past the "thin plate" center area of the BC to obviate its warping which doesn't provide sufficient stiffness to keep the SB in place without movement

The prototype is made of 3/8" aluminum for ease of fabrication. Ideally a permanent SBB will be 1/4" steel, although the thinner steel solution will require some additional fabrication that the thicker aluminum prototype didn't.
