MACERATOR:

USED MY2016 TO CURRENT.

PART #0303362; THETFORD: PUMP,MACERATOR THETFORD SANI-CON TURBO
MODEL #97646 WIWHT 30' HOSE/SLEEVE

COMPLAINT: CS THE MACERATOR WILL NOT RUN OR RUNS BUT WILL NOT
PUMP .

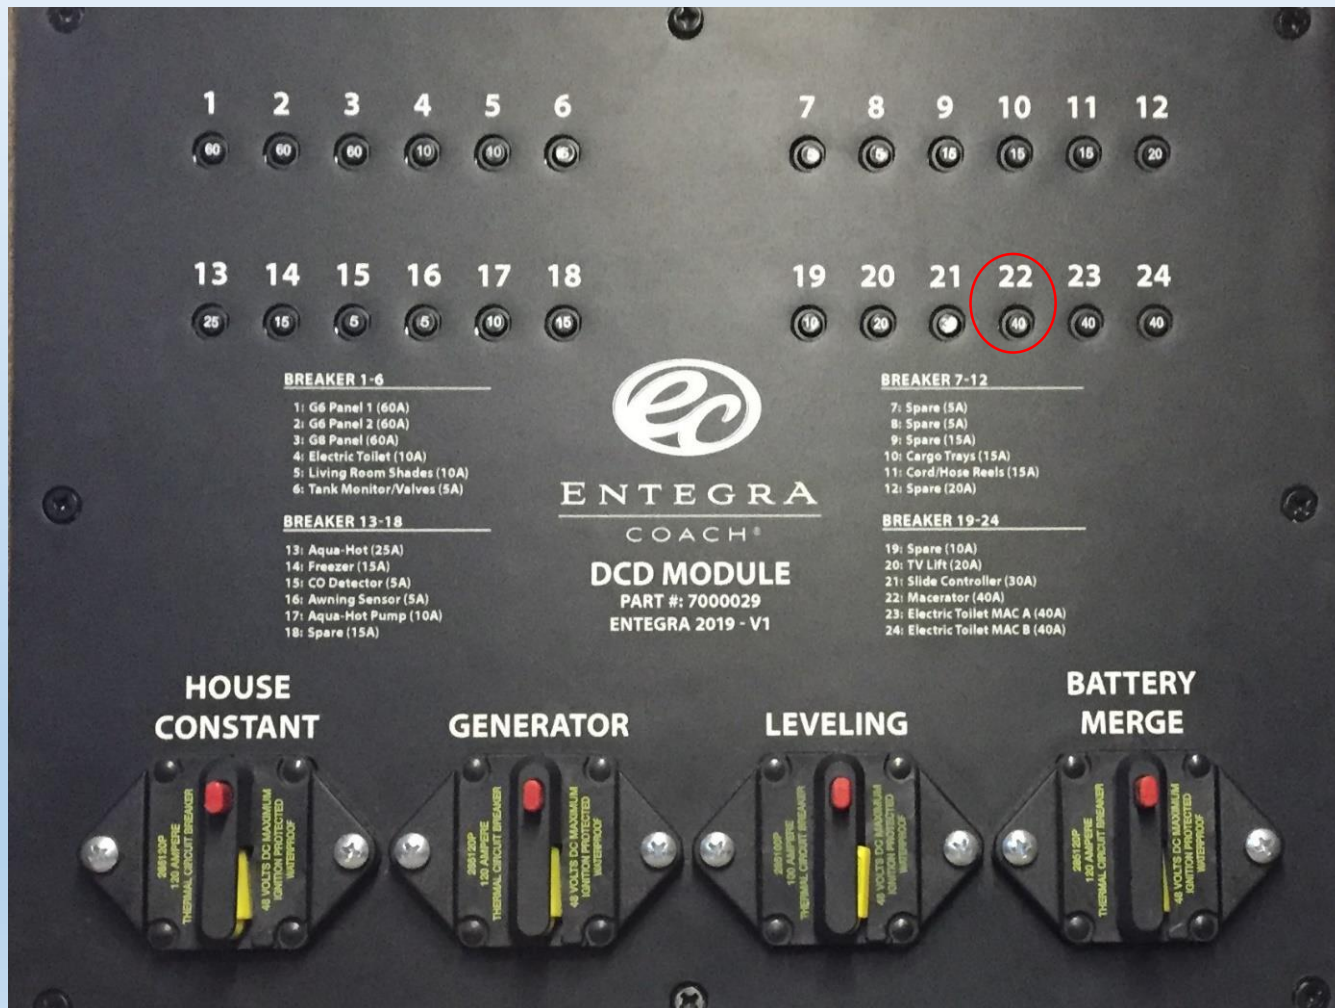
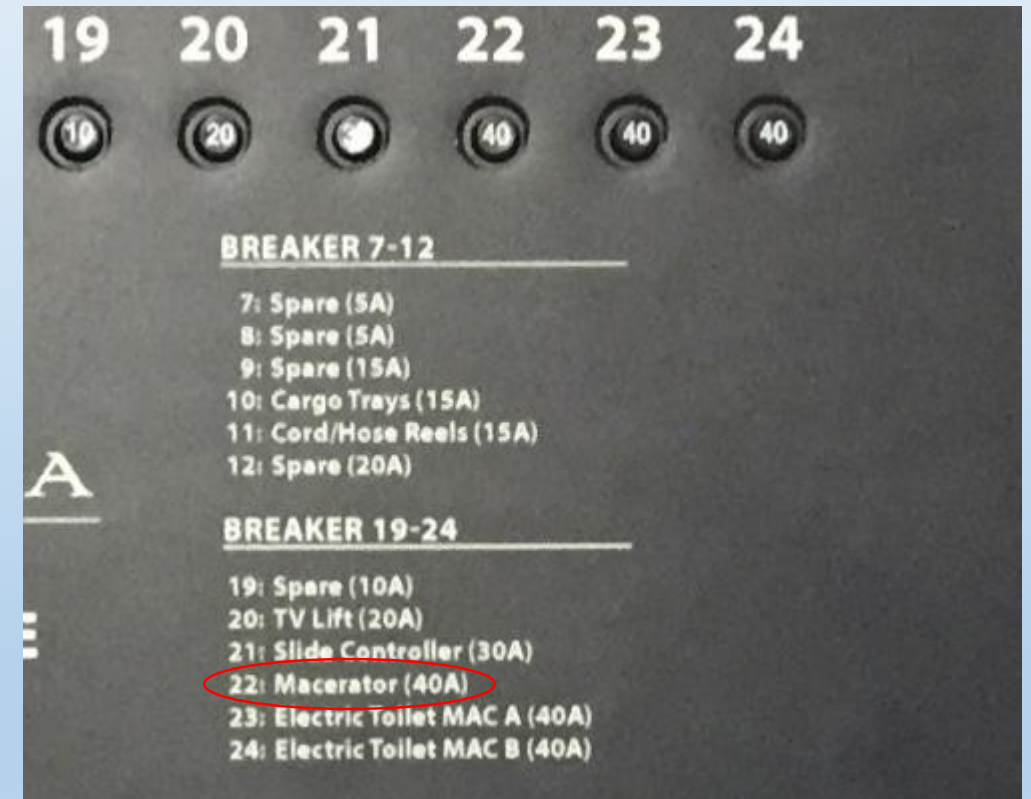
MY 2019

CAUSE #1.: THE BREAKER FOR THE MACERATOR IS TRIPPED OFF AT THE DCD BOARD ON THE PASSENGER SIDE BATTERY COMPARTMENT.

DCD BOARD IS LOCATED ON THE PASSENGER SIDE, REAR BULKHEAD, BEHIND THE CARPETED PANEL.

CORRECTION: CHECK AND RESET BREAKER IF IT IS TRIPPED.

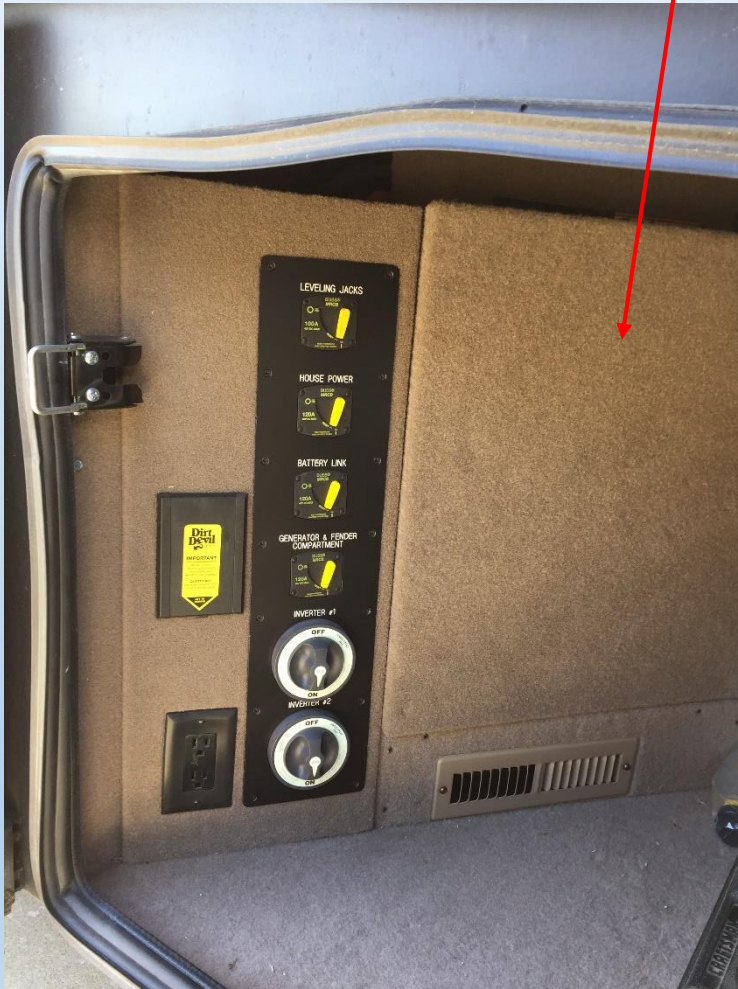
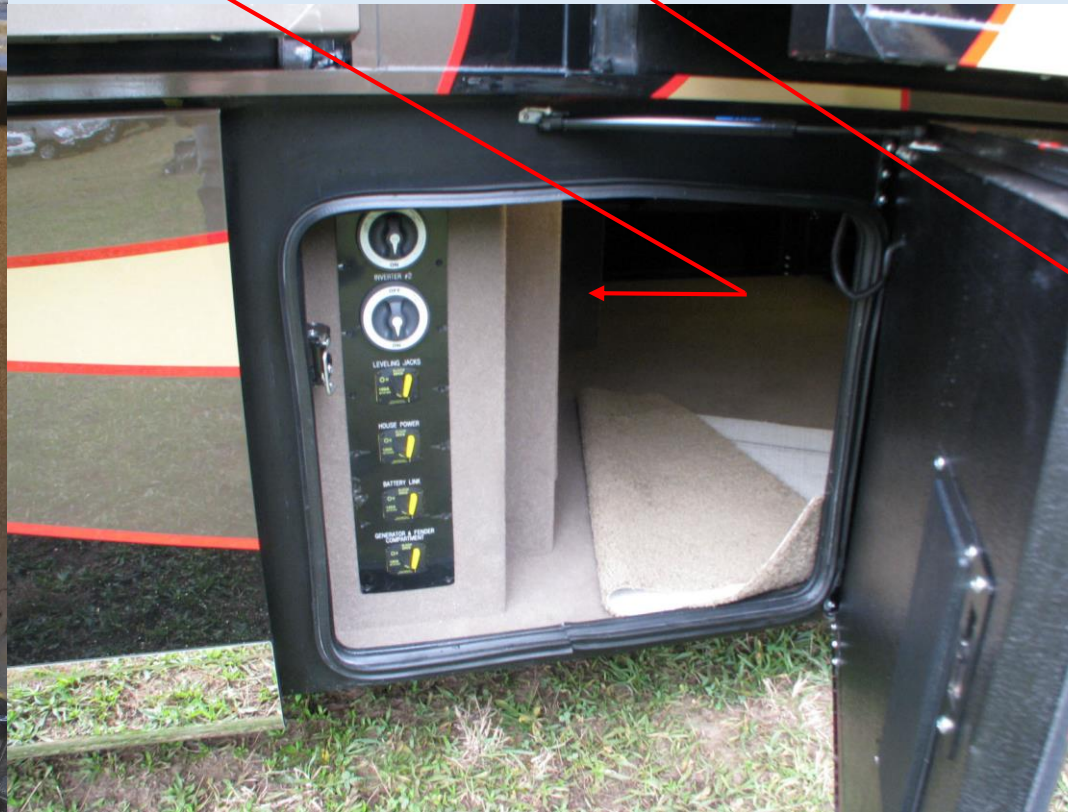
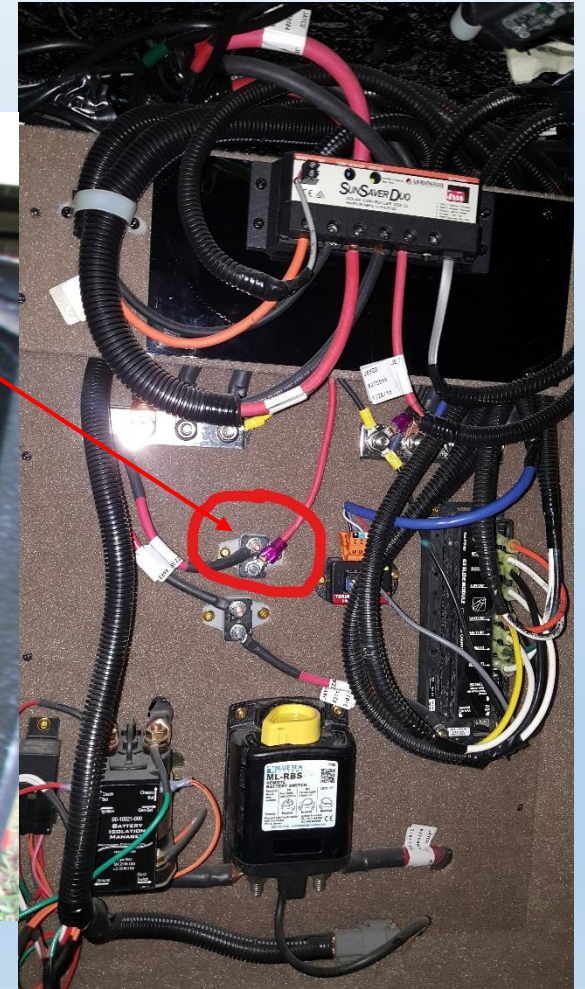
MY2017 & 2018:

CAUSE #1: CHECK FOR POWER AT THE MINI BREAKER LOCATED ON THE PASSENGER SIDE, REAR BULKHEAD, BEHIND THE VELCRO CARPETED PANEL.

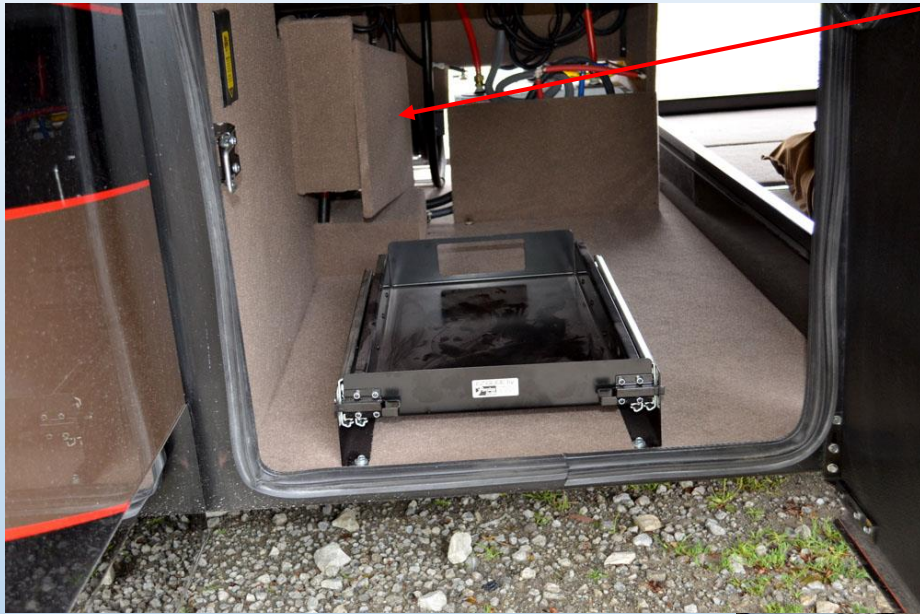
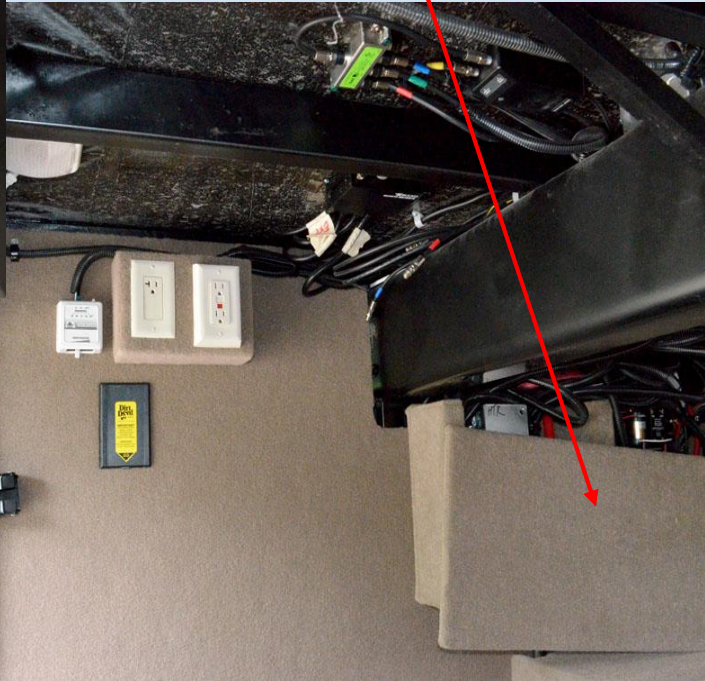
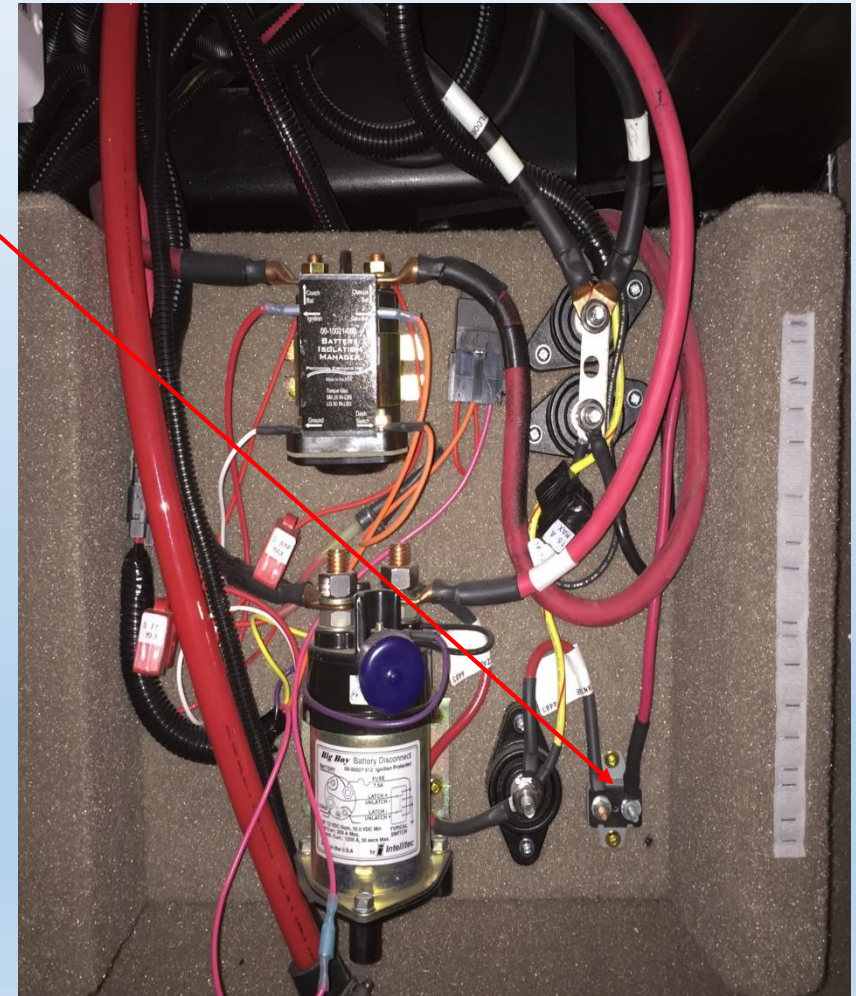
MY2016:

CAUSE #1: CHECK FOR POWER AT THE MINI BREAKER LOCATED ON THE PASSENGER SIDE, REAR BULKHEAD, BEHIND THE VELCRO REMOVABLE CARPETED PANEL.

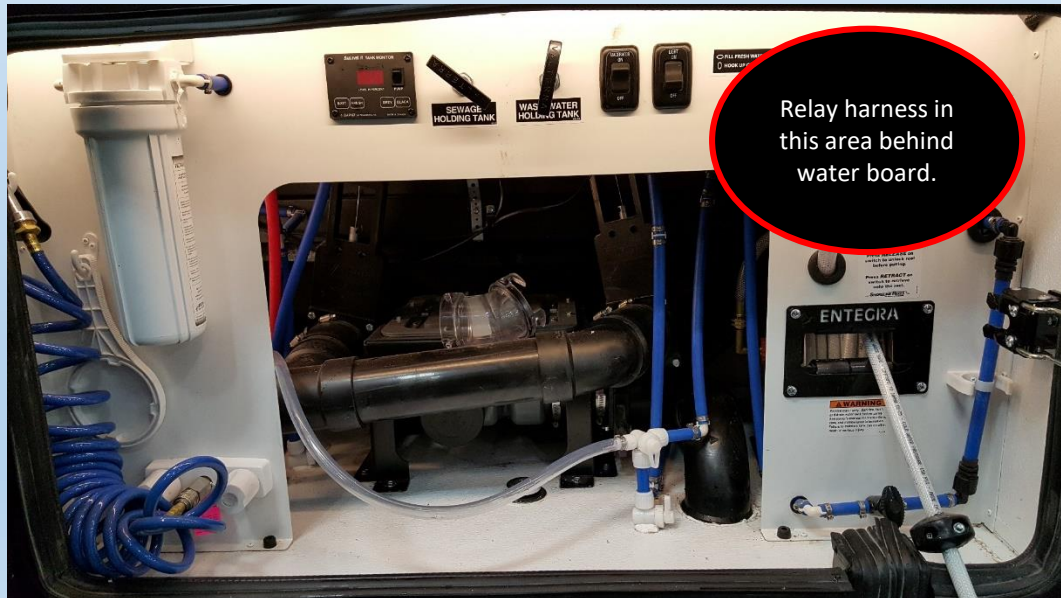
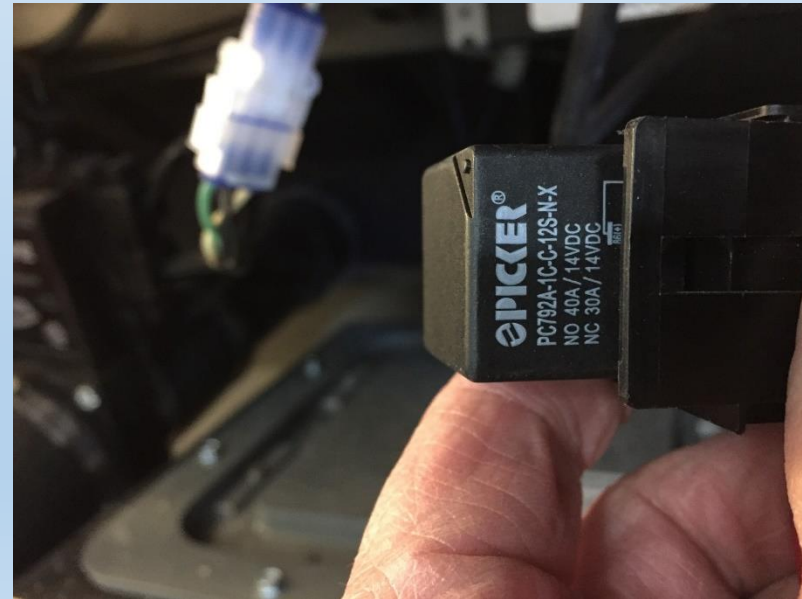
CAUSE #2: THE RELAY IN THE WET BAY HAS FAILED AND ONLY CLICKS WITHOUT SENDING POWER TO MACERATOR MOTOR. TEST POWER AT RELAY INPUT AND OUT PUT TO THE MACERATOR.

THE RELAY IS LOCATED ON THE RIGHT SIDE OF THE WET BAY BY OR BEHIND THE COVER BOARD NEAR THE WATER HOSE REEL.

CORRECTION: TEST AND REPLACE THE RELAY AS NEEDED.

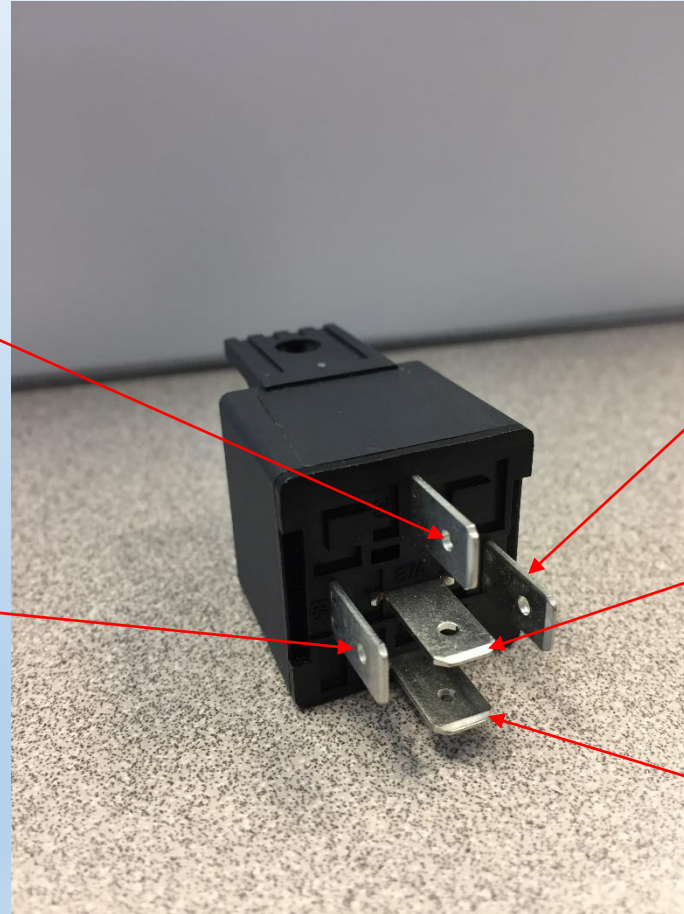
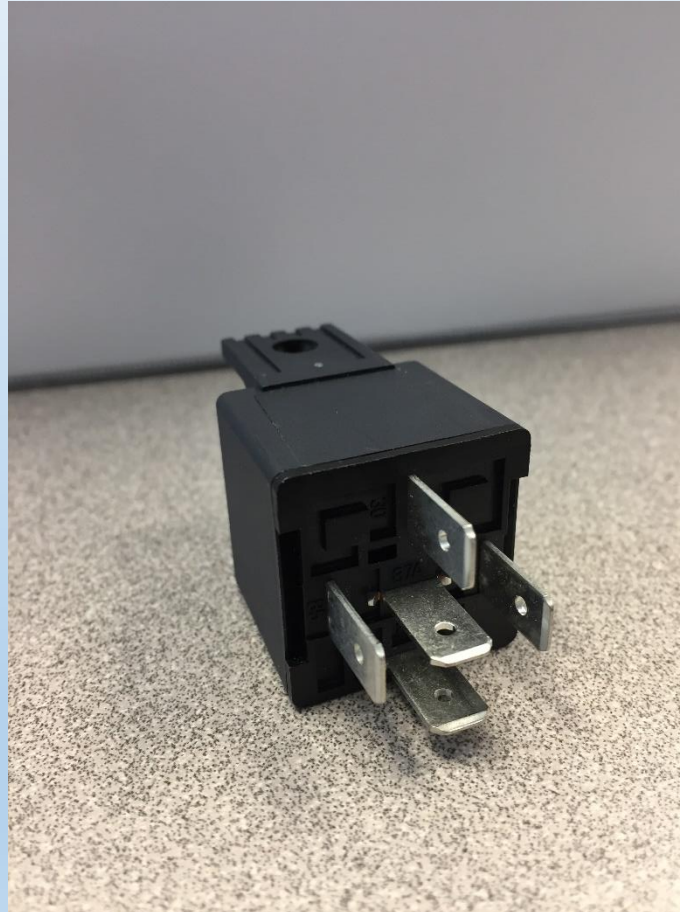
MACERATOR SWITCH ON CONNECTS GROUND TO #85.
CHANGES 12V B+ FROM TERMINAL #87A TO #87.

#30, 12V B+ FEED TO RELAY

#85, GROUND

#86, 12V B+

#87A, 12V B+ WITH GROUND
INCOMPLETE; SWITCH OFF.

#87, 12V B+ WITH GROUND
COMPLETE; SWITCH ON.

WITH SWITCH OFF, TEST FOR 12V B+
AT TERMINAL #30 AND #87A.
USE ANY GROUND.

WITH SWITCH ON, TEST FOR
12V B+ AT TERMINALS #30
AND #87. USE ANY GROUND.

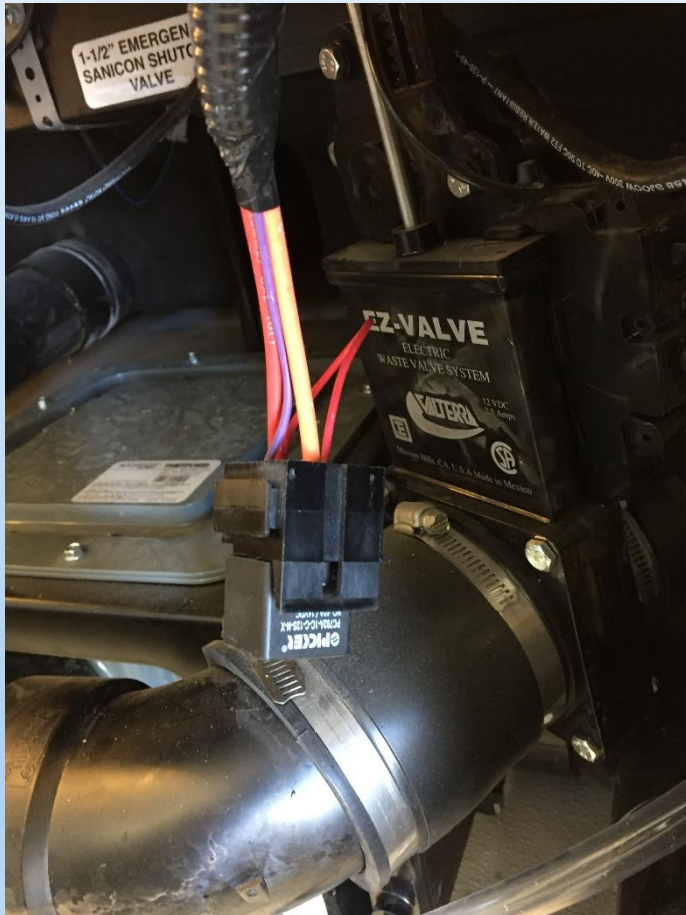
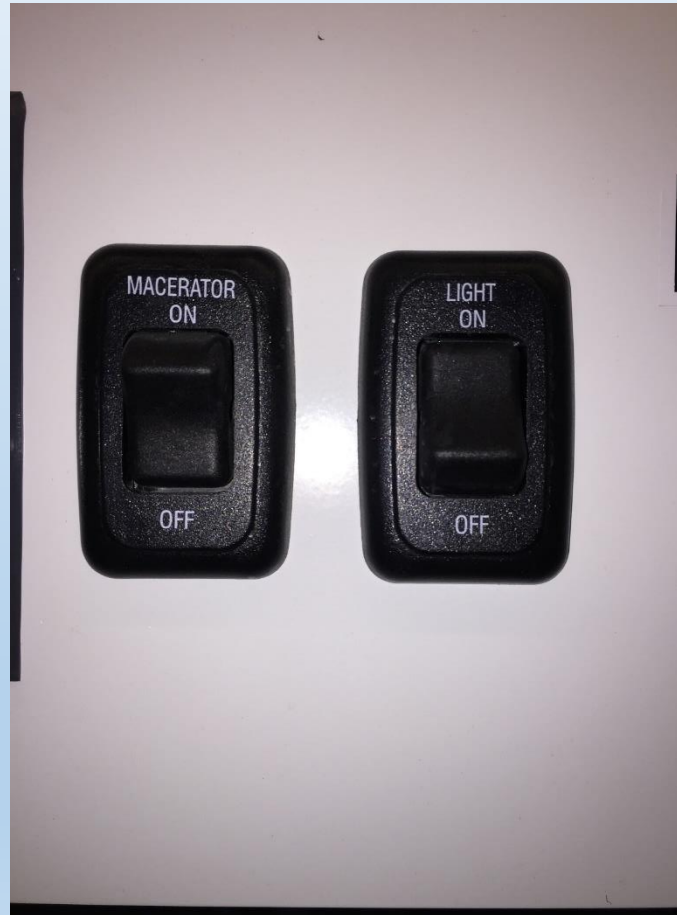
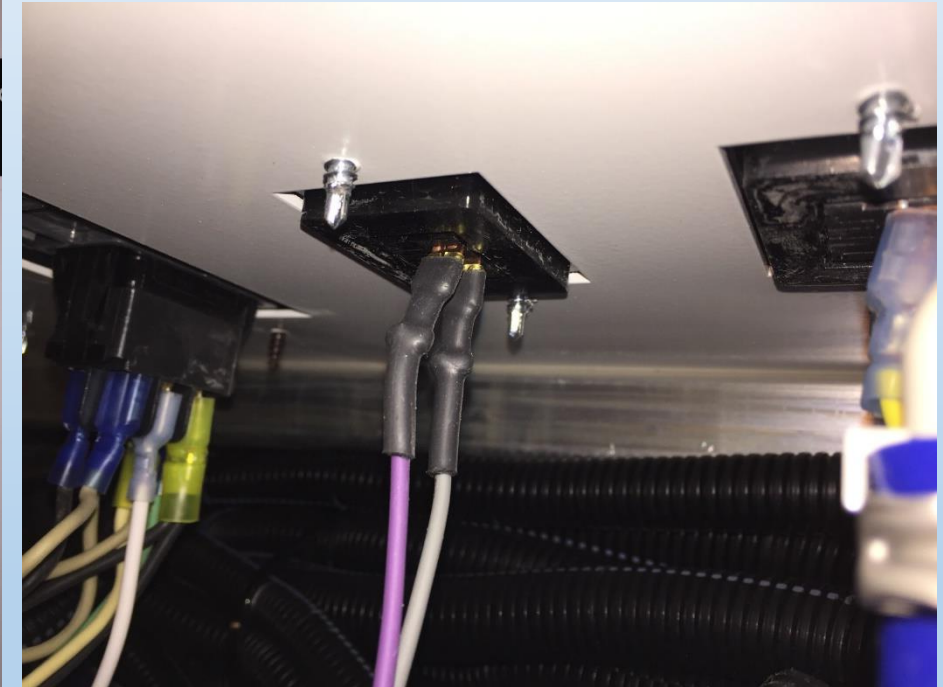
CAUSE #3: THE MACERATOR SWITCH HAS FAILED OR WIRES HAVE LOST CONNECTION AT THE SWITCH OR THE RELAY IN THE WET BAY.

THIS PHOTO IS LOOKING UP UNDER NIETH THE WATER BOARD.

CORRECTION: CHECK WIRE CONNECTIONS ON THE RELAY AND SWITCH IN WATER BAY BOARD.
