WIPER ARM INSTALLATION

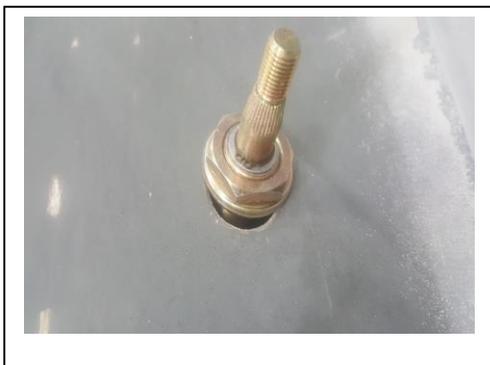
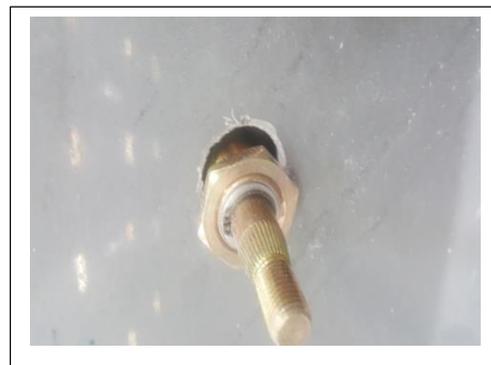
Depending on the level of "sloppiness" is more than likely a result of repeated removal/installation of the wiper arms. The pivot shaft splines may be be "Loaded" with material from the wiper arms. The pivot shafts are made of hardened steel and are not stripped, simply loaded with the soft material from the wiper arm head. The splines on the pivot shaft can be cleaned using a utility knife or wire brush before the install of the new arms.

The Curb side wiper arm should be installed with the blade parallel with the bottom of the windshield. Tighten the nut that hold the arm to the pivot shaft and torque to 65ft. lbs. Do not operate the system at this point. Wait approximately 45 minutes and re-torque to 65 ft. lbs.

The Driver's side arm should be parked in the position where the outer tip of the wiper blade will be setting approximately 1"-1.5" above horizontal. Tighten the nut that hold the arm to the pivot shaft and torque to 65ft. lbs. Do not operate the system at this point. Wait approximately 45 minutes and re-torque to 65 ft. lbs.
