Erosion/River/Channel Wear

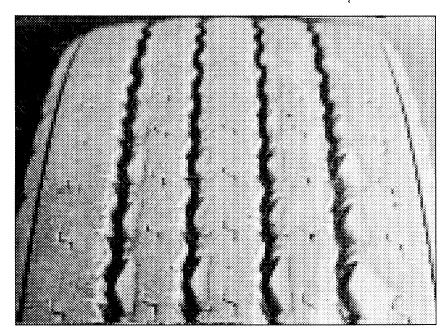
Circumferential wear along rib edges next to major tread grooves may be wavy in appearance and vary in width around tire.

Characteristic of slow wear rate of radial tires on free rolling axles. May vary with individual tire tread design and construction. Common in line haul operations in which loads are light and turning is frequent.

| TIRE | Erosion wear should not be of concern. |
| VEHICLE | None |
| OPERATIONS | None |
