Technical Service Bulletin Number
--

TSB150130

Intake Valve Chordal Failures

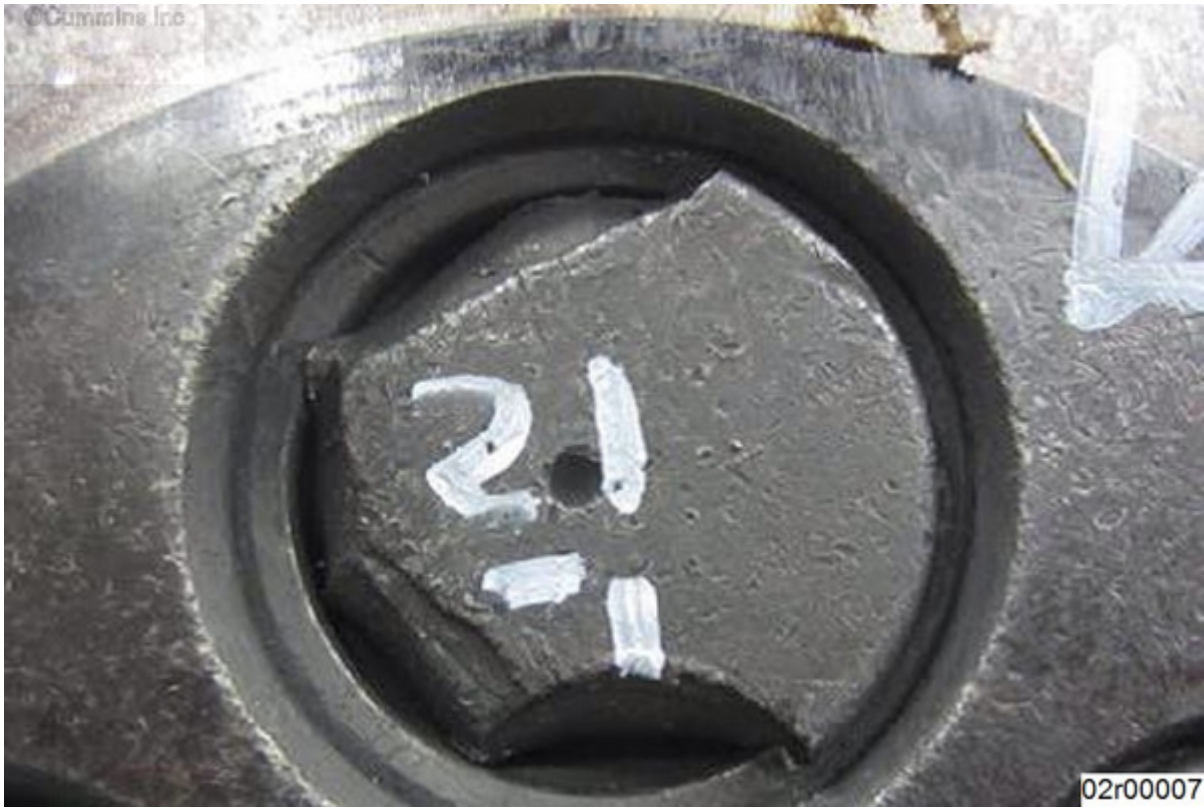
A chordal failure of an intake valve is characterized by a piece or pieces of valve head missing from an intake valve. Refer to Figure 1 and Figure 2 below. Visual inspection of turbocharger and exhaust plumbing may reveal the presence of metal debris or, in instances of turbocharger failures, foreign object damage may be observed.

Figure 1: Broken Intake Valve in Cylinder Head

Intake valve, Part Number 3685996, has been released to address chordal failures and commonize intake valve part numbers across all ISX and QSX cylinder heads. The intake valve is manufactured from premium materials and improves robustness against acidic corrosion and thermal fatigue that are primary contributors to chordal failures. The intake valve seat remains unchanged.

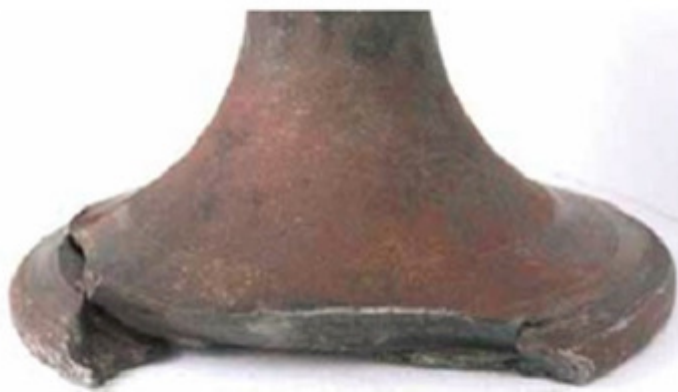
02r00008

Under severe operating conditions, acidic corrosion and thermal stresses induced in the intake valve can initiate fatigue cracking which, over time, can propagate until a portion of the intake valve separates from the valve head and enters the cylinder. This type of valve failure is commonly known as a chordal failure. Once failed, performance of the engine is compromised and progressive damage to the piston, cylinder liner, cylinder head and turbocharger can occur. Typical complaints following intake valve chordal failures include but are not limited to check engine light, low engine power, cylinder misfire, "popping" noise from the air intake manifold, excessive engine noise, and engine shut down and no start conditions.

Figure 2: Broken Intake Valve Showing Radial/Chordal Fracture
