On March 30th 2013 I purchased from M&M Camping Center in Trenton, MI a brand new Cruiser Viewfinder Signature Travel Trailer, model 28BHSS. Attached to this letter you will find a summary of 27 items which have required repair during the first 7 months of use most of which are due to poor assembly workmanship.

Summary List of Repairs for Cruiser RV Travel Trailer

Model # 28BHSS

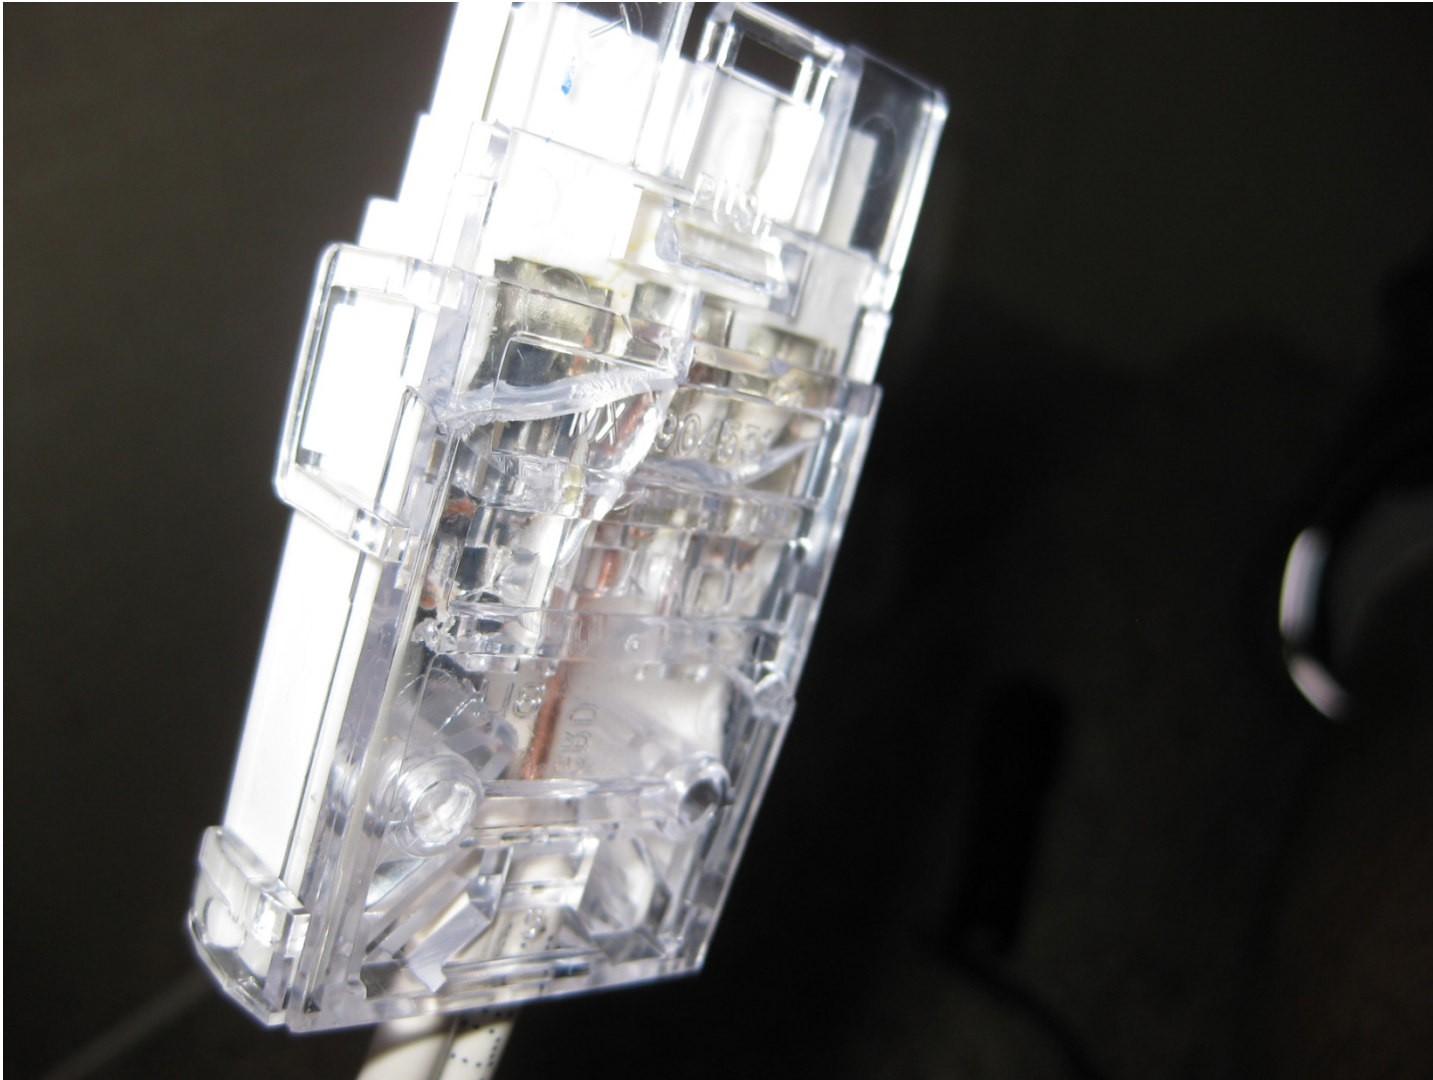
Cracked cover due to wires not dressed properly

12. Replace Molex Power Connector Inside Slideout –The 110V outlets on the slideout were intermittent. Both sides of the Molex power connector were found to be damaged and needed to be replaced (see attached photos) The guy who assembled this connector must have known he broke it and just passed it along. The housing is severely cracked on one side, and the terminals are bent on the other side. He even drove a mounting screw right through the conductor wire.

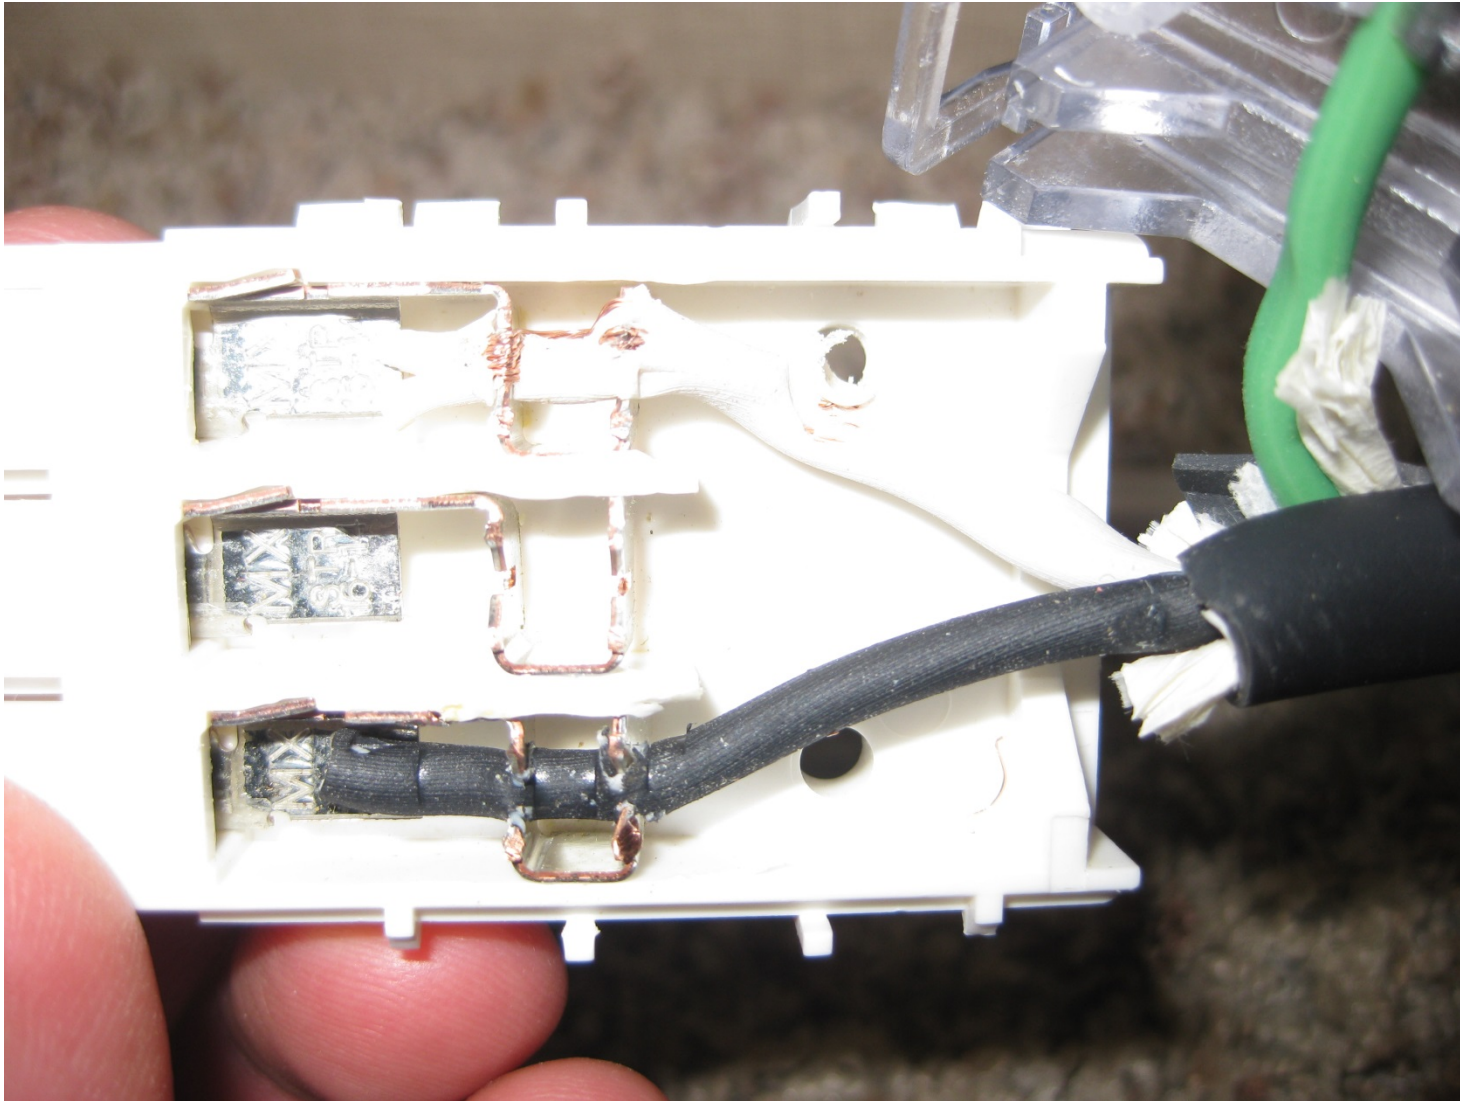
Damaged Terminals

This image shows a close-up of a white RJ45 network connector. The connector is partially disassembled, revealing the internal metal contacts and the wiring. Two labels with black lines pointing to specific areas are present. The label 'Damaged Terminals' points to the top two metal contacts where the copper wires are inserted. The label 'Wire damaged/crimped by cover' points to a black wire that is bent and appears to be caught or crimped by the white plastic cover of the connector. The background is a blurred, textured surface.

Wire damaged/crimped by cover

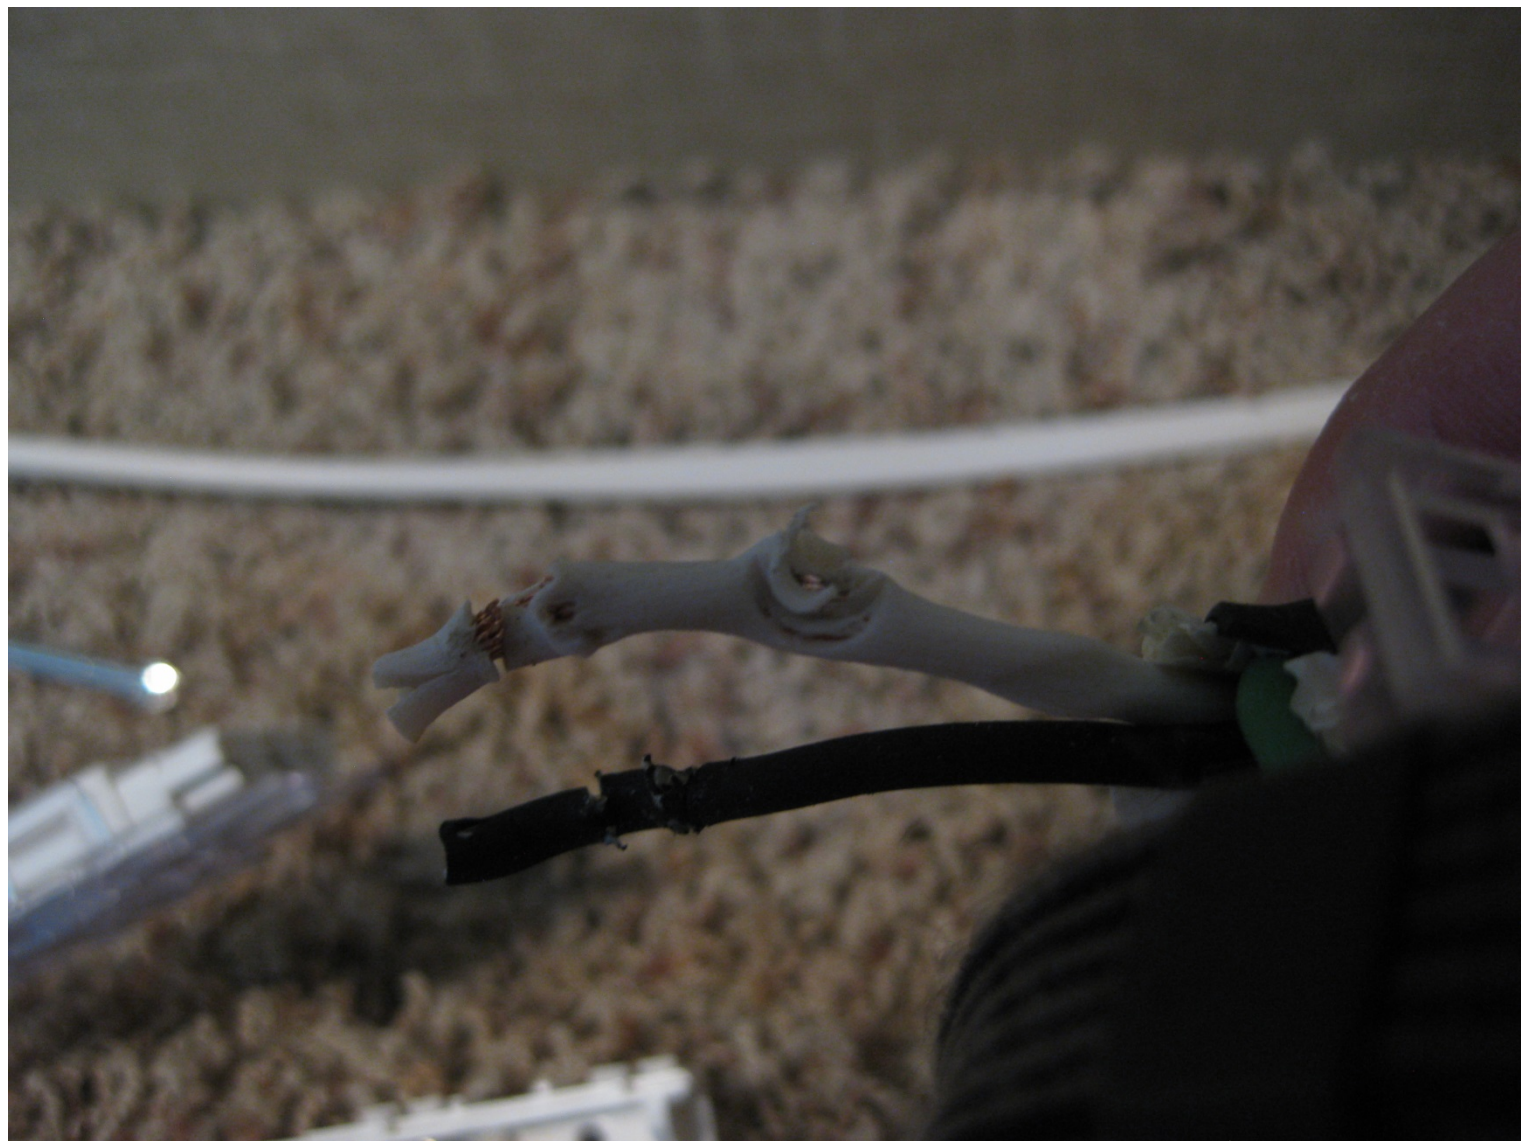
Mounting screw was driven through the white conductor creating an intermittent connection and a potentially dangerous condition

I believe it is reasonable for a new owner to expect a return visit to the dealership for a few minor repairs, but the quantity and type of repairs this trailer has required is unacceptable. I ask that you review the attached detailed list and in particular review the issue with the Molex power connector (pictures included) which presented a potentially dangerous condition as a mounting screw was driven through a 110Volt conductor.
