Carefree Of Colorado Electric Patio Awning Gear Pack

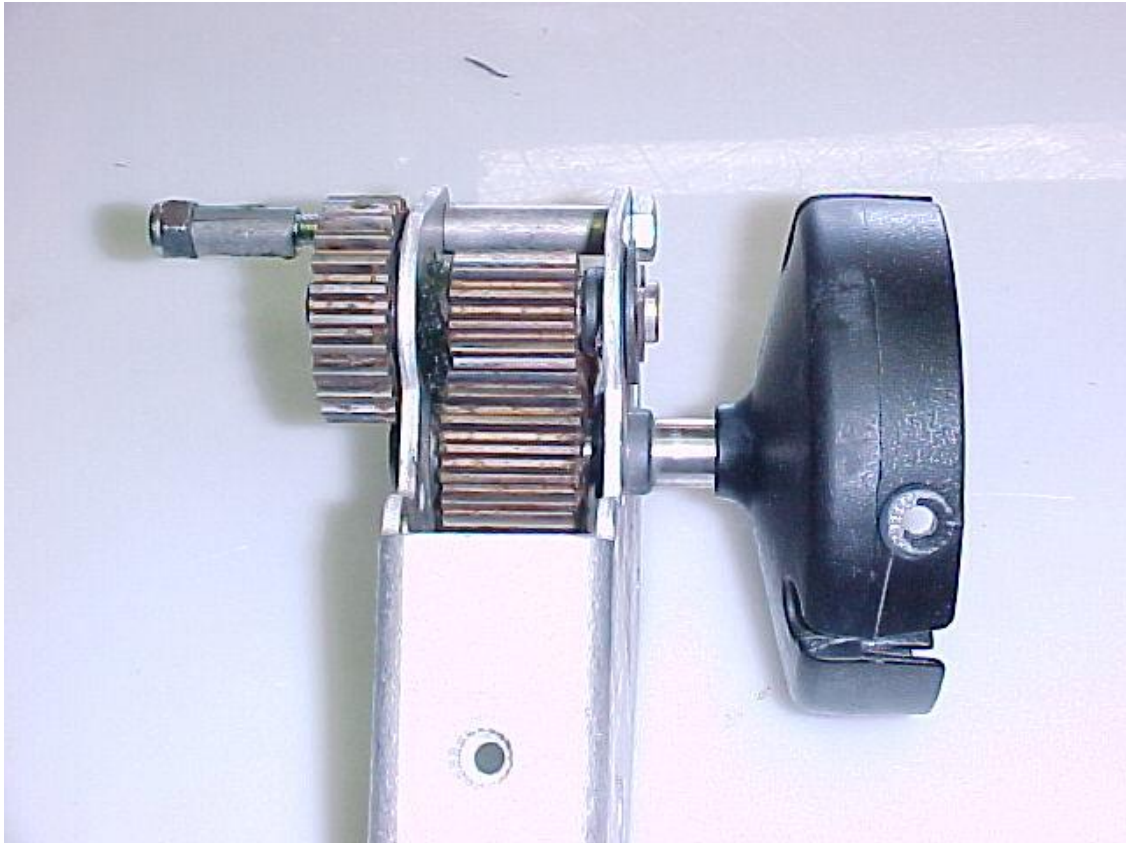
This gear pack is located inside the black plastic enclosure on the front awning arm. The drive motor in this picture has been removed. The bolt on the left side of the gear pack is one of three that the motor is bolted on with. The black bell shaped cap is attached to the awning tube the awning material rolls onto.

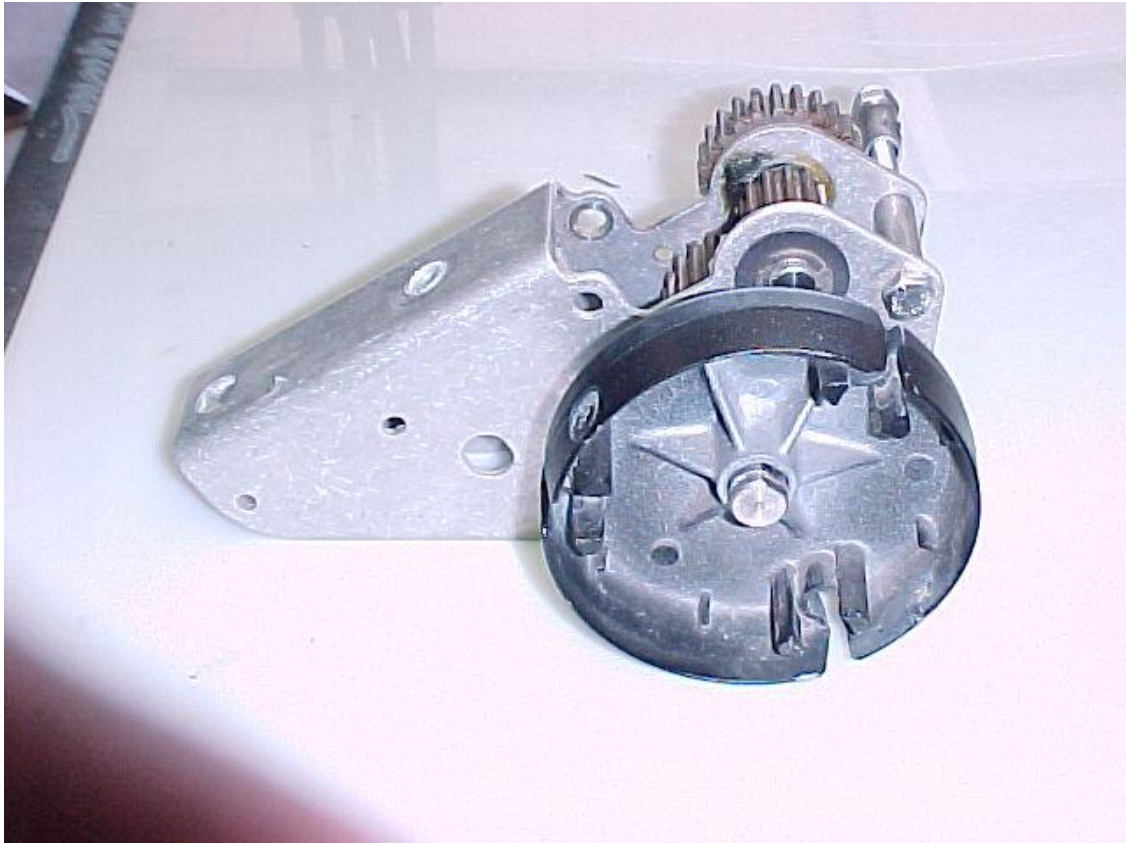
Another view of the bell cap.

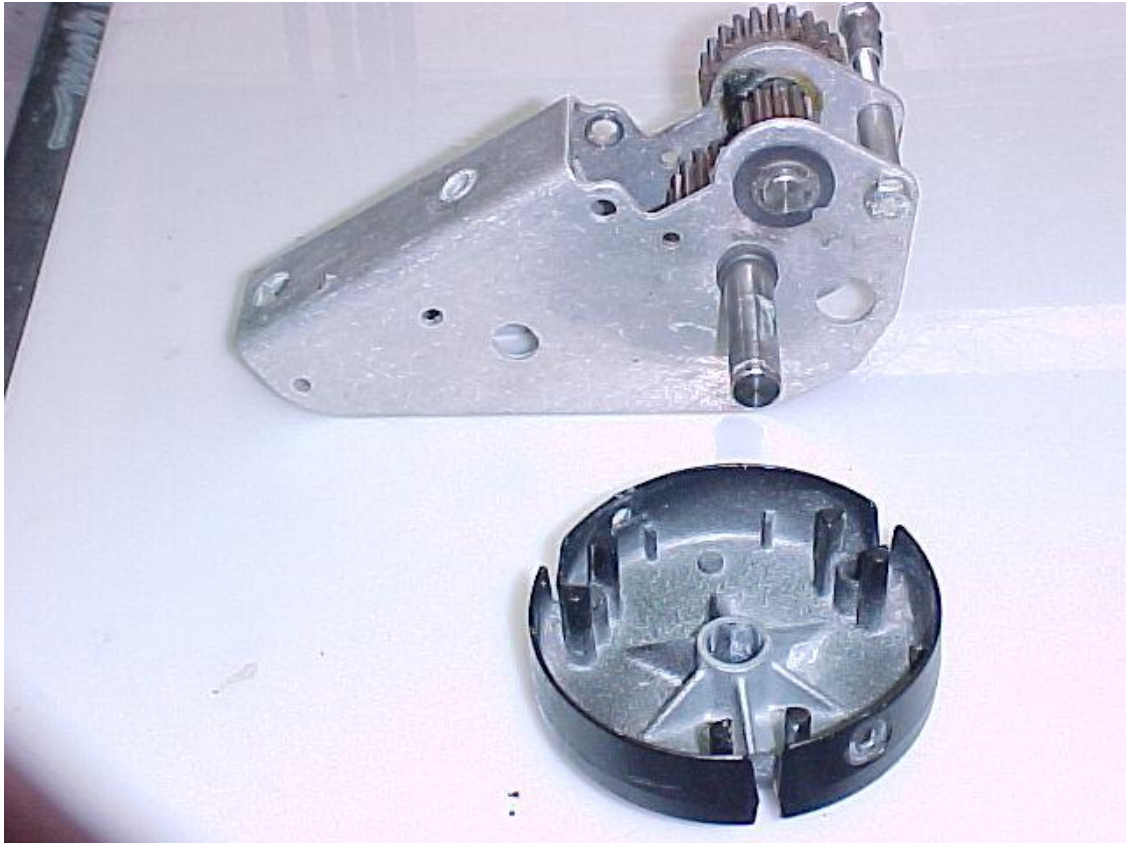
Bell cap removed from gear pack shaft.

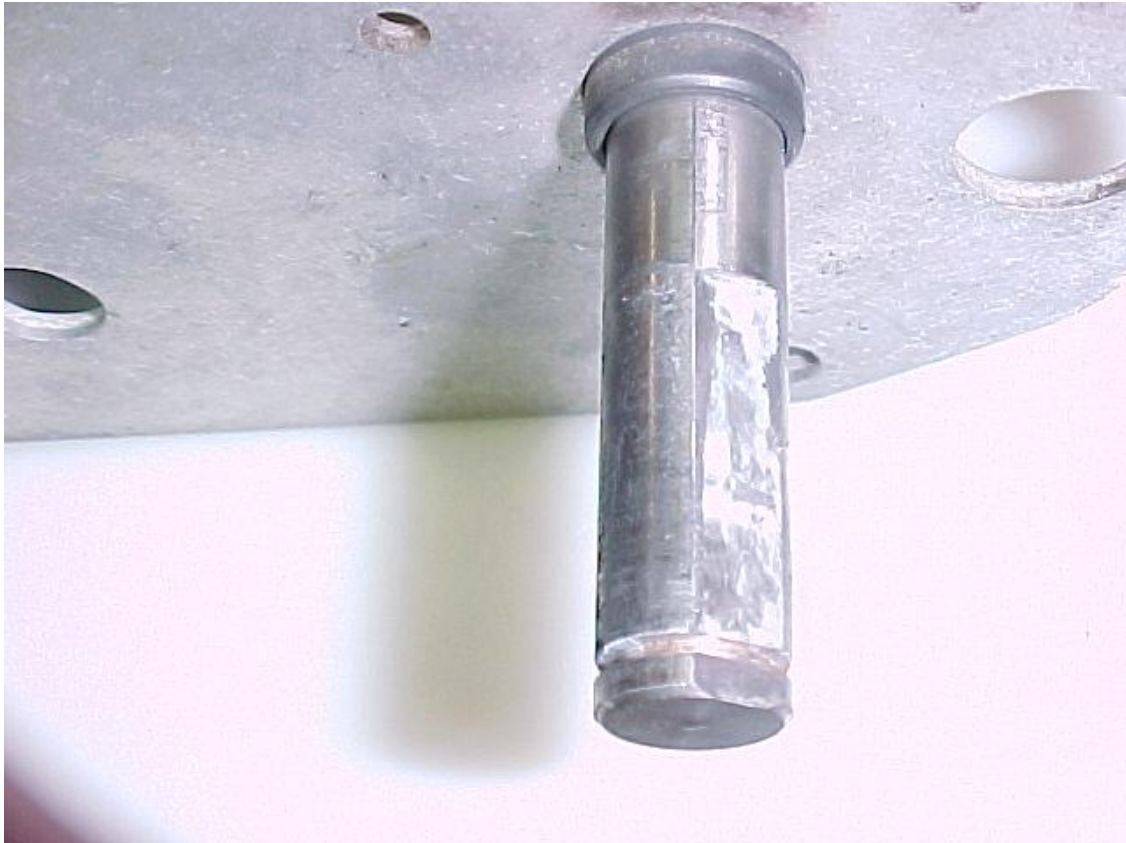
Note the flat area on the shaft. This mates up with a flat on the inside of the bell cap sleeve. (See next picture) This is supposed to keep the shaft and bell cap rotating together.

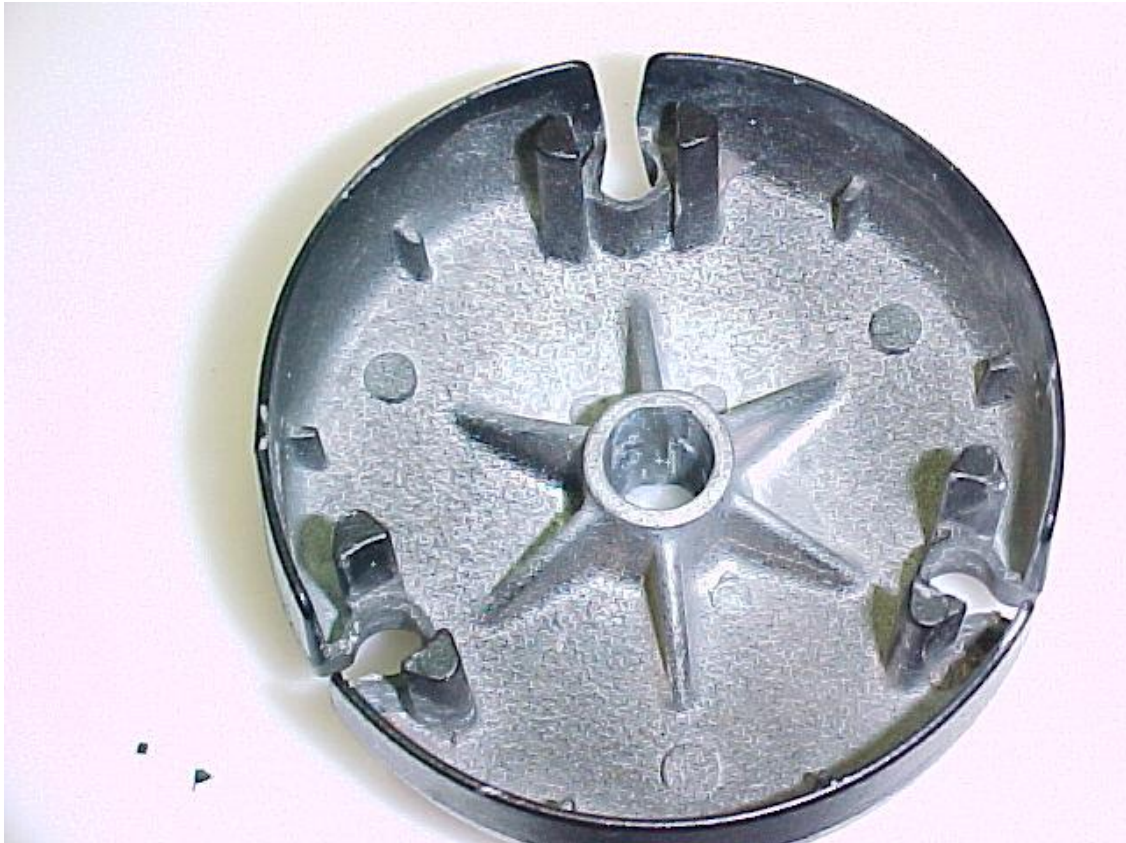
The Flat is barely visible due to the shaft turning inside the sleeve and wiping out the flat.

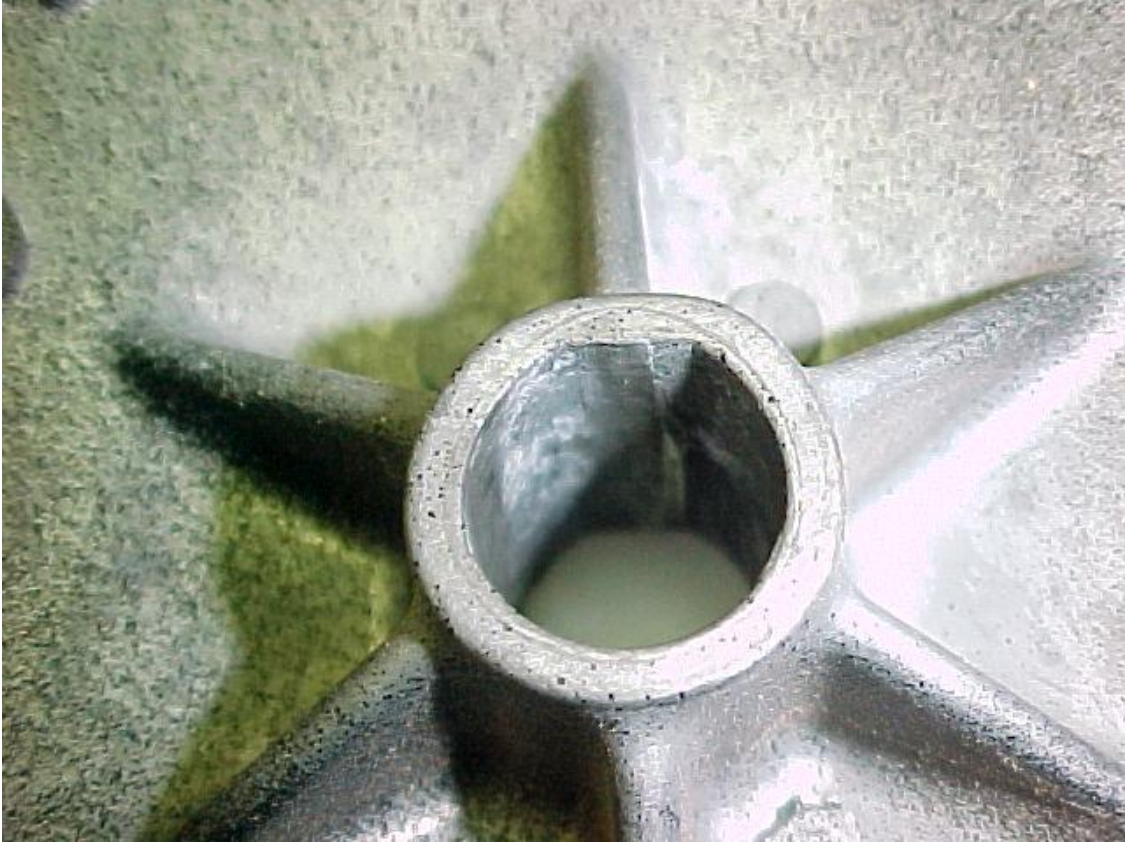
A closer view.
