MACERATOR:

USED MY2016 TO CURRENT.

PART #0303362; THETFORD: PUMP,MACERATOR THETFORD SANI-CON TURBO
MODEL #97646 WIWHT 30' HOSE/SLEEVE

COMPLAINT: CS THE MACERATOR WILL NOT RUN OR RUNS BUT WILL NOT
PUMP .

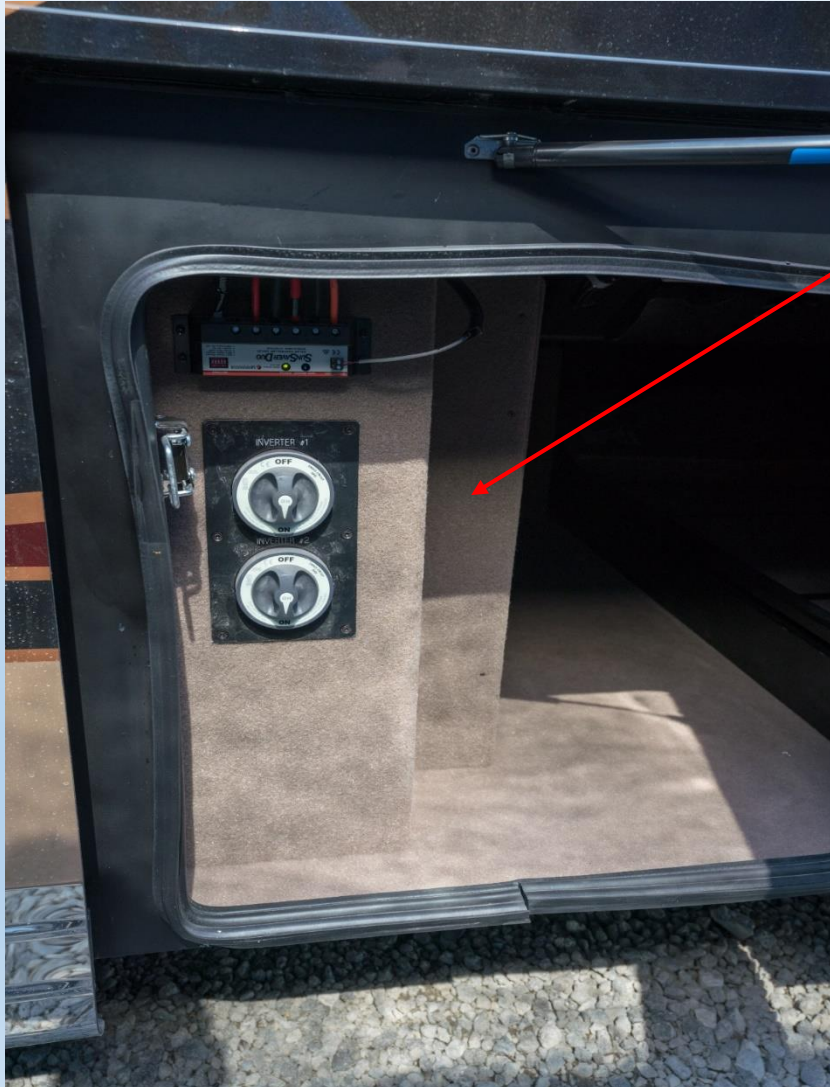
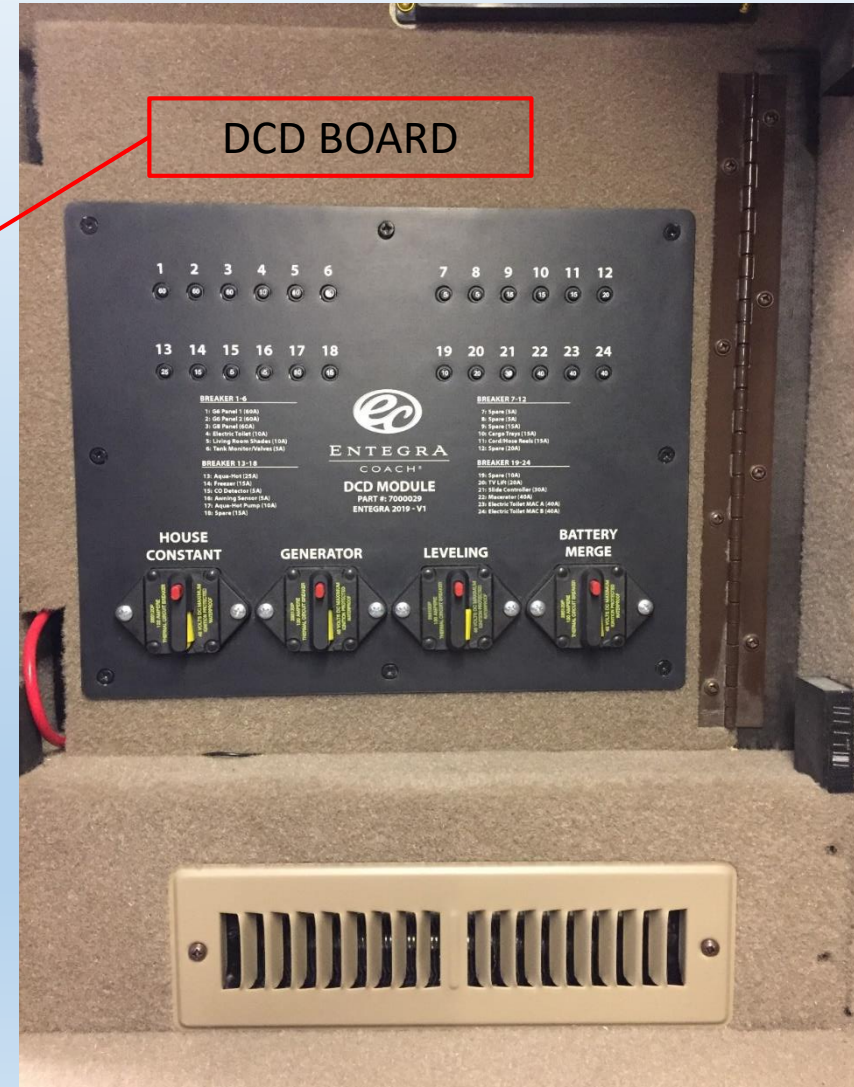
CAUSE #1.: THE BREAKER FOR THE MACERATOR IS TRIPPED OFF AT THE DCD BOARD ON THE PASSENGER SIDE BATTERY COMPARTMENT.

DCD BOARD IS LOCATED ON THE PASSENGER SIDE, REAR BULKHEAD, BEHIND THE CARPETED PANEL.

CORRECTION: CHECK AND RESET BREAKER IF IT IS TRIPPED.

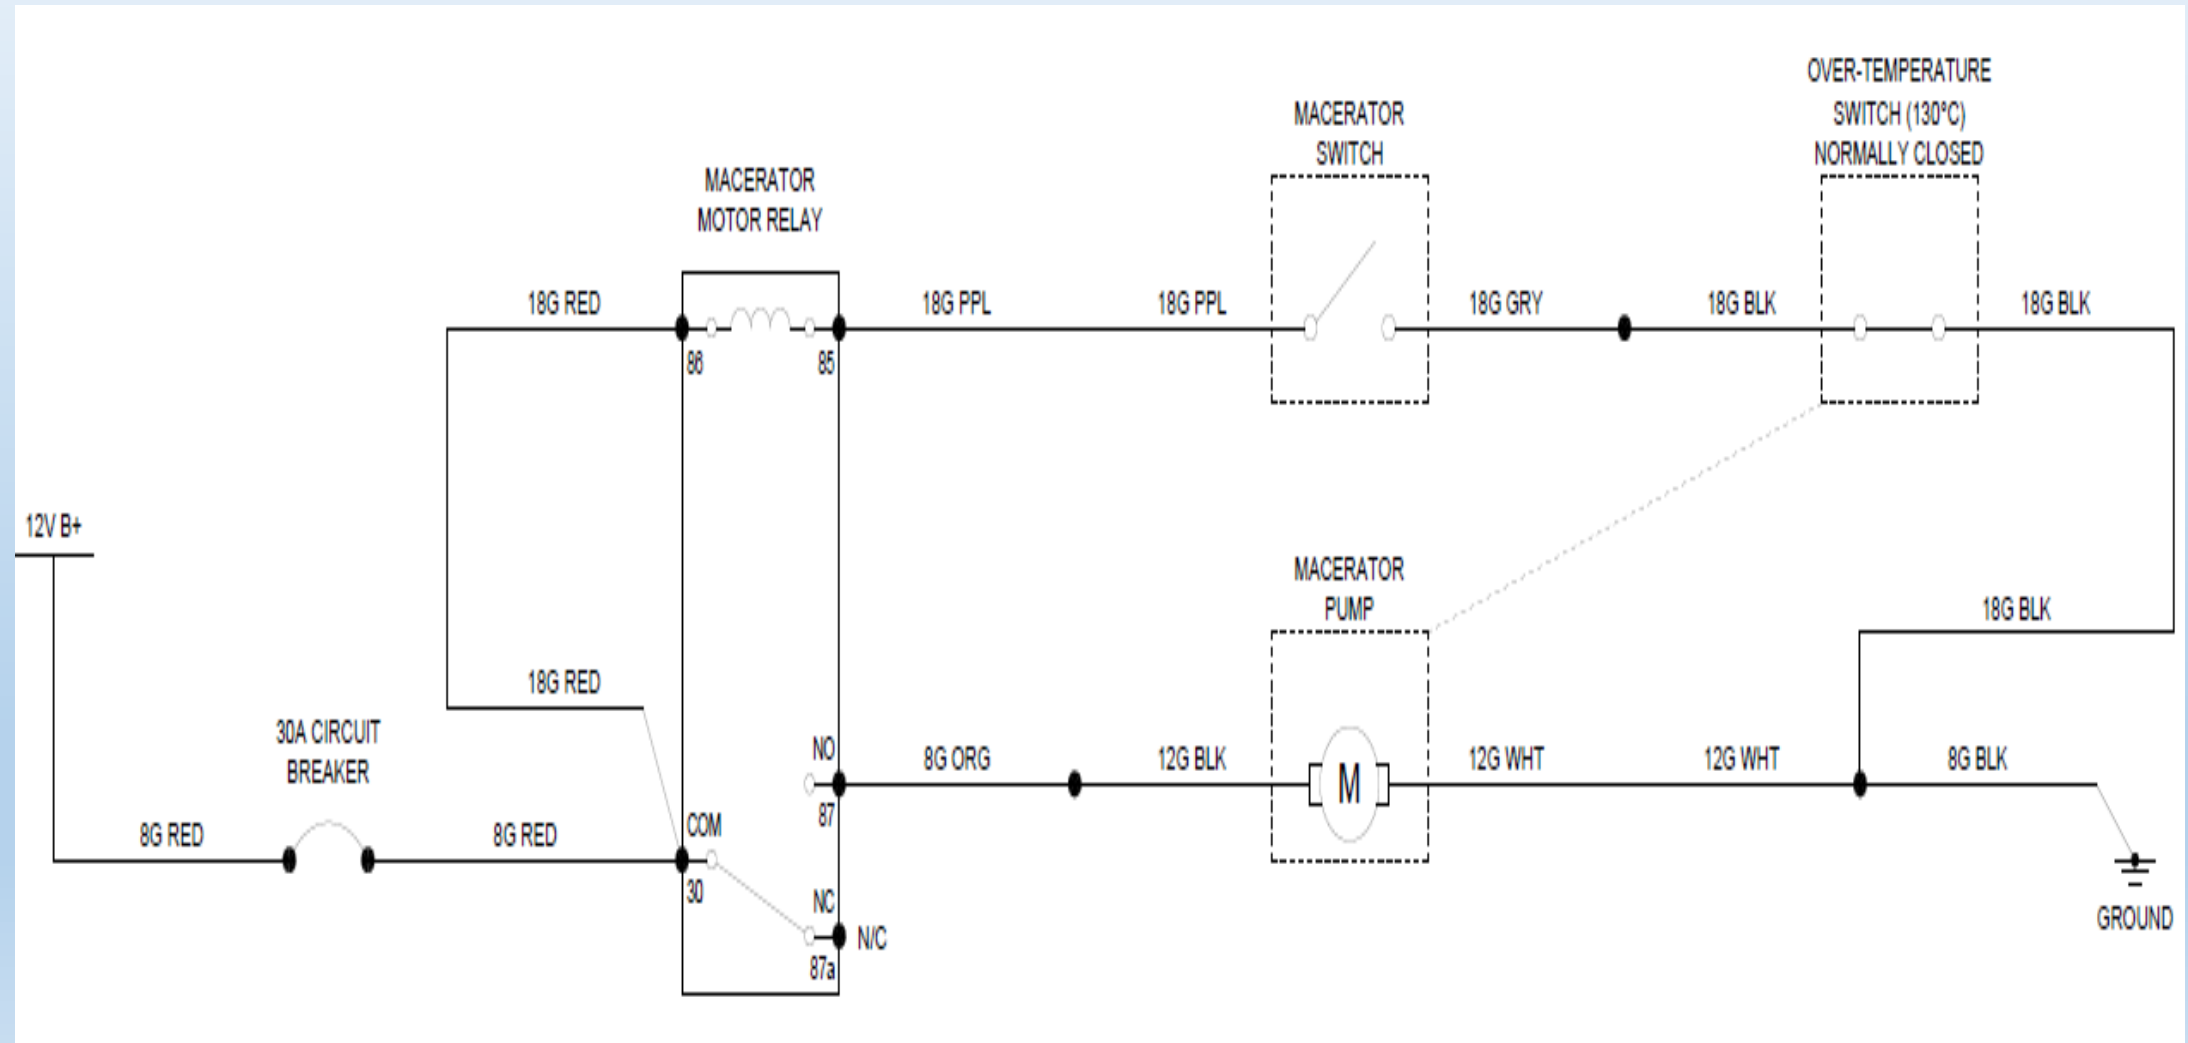
System Schematic

CAUSE #2: THE RELAY IN THE WET BAY HAS FAILED AND ONLY CLICKS WITHOUT SENDING POWER TO MACERATOR MOTOR. TEST POWER AT RELAY INPUT AND OUT PUT TO THE MACERATOR.

CORRECTION: TEST AND REPLACE THE RELAY AS NEEDED.
