Scott Wixson  
Customer & Product Support Manager, Specialty Vehicles  
Hunter Smith  
Customer & Product Support Lead, Specialty Vehicles  
Spartan Motors  
1541 Reynolds Road  
Charlotte, MI 48813

This letter will provide information regarding a serious Spartan-related on-the-road failure Amy & I recently experienced with our 2018 Entegra Cornerstone.

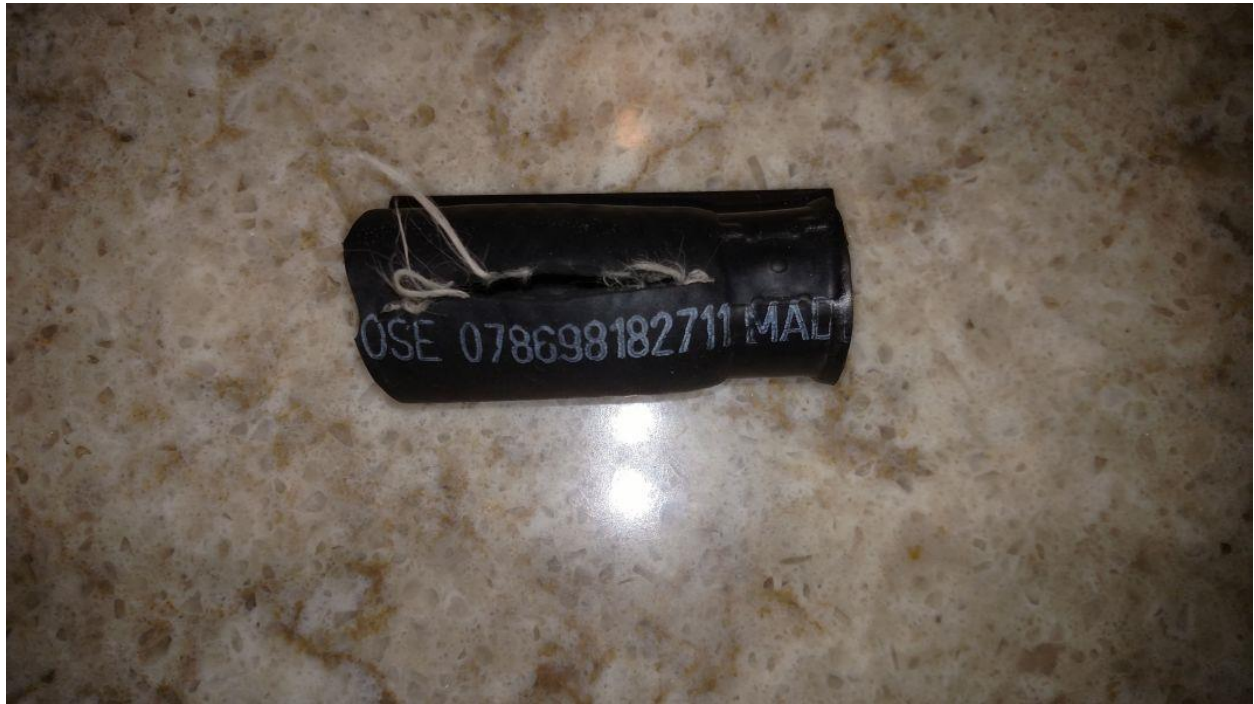
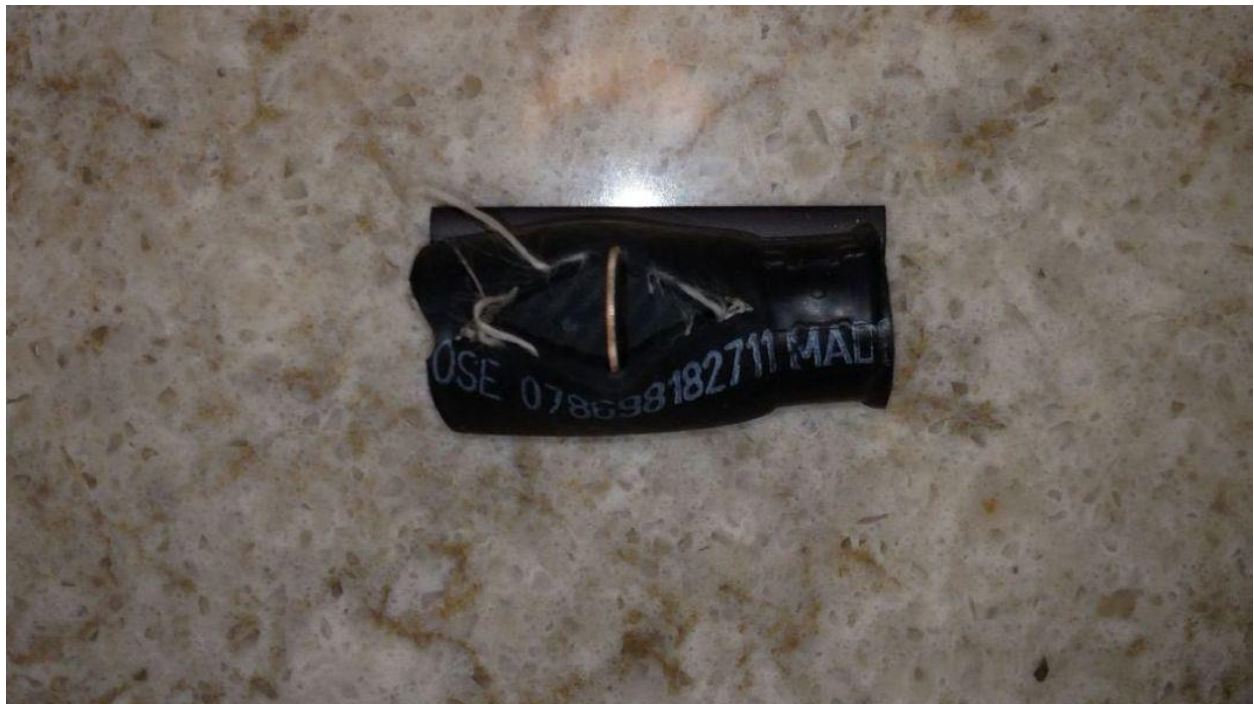
After adding several gallons of water to the recovery tank, I noticed water/coolant running out onto the ground under the coach. Crawling under the coach, I determined it was coming from a split in a 3/4" I.D. heater hose, near where the hose connected to a quarter-turn shut-off valve. I assumed that shut off valve and another one near it were related to the loop of heater hose that runs from the engine up to the dash heater core and back. Since then, I've learned there is a similar loop for the Aqua-Hot pre-heat function, so at this point I'm not sure which loop the failed hose was part of.

My next step was to cut off the failed section of hose. Below are two photos, the second of which has a dime inserted in the split of the hose to provide some perspective. This section of hose is about 2.5" long and the split is about 1.75" long.

Fortunately, there was enough slack in the hose to allow me to reconnect the hose to the fitting on the shut off valve after cutting off the failed section. I did that, topped off

While I'm not an expert on heater hose, I have plenty of experience with it. Examining the failed section of this particular hose, it doesn't appear to me to be particularly high-quality hose. And a failure like this one at less than two years and just under 24,000 miles would suggest the hose was wholly inadequate for the application. I'd like to believe this wasn't a case of an uninvolved purchasing agent taking the lowest of X number of bids without regard for quality, but in any case I'm not exactly confident we won't experience another hose failure at some point in the future – perhaps the near future.

Maybe you'll tell me this is the first such failure Spartan has ever seen. Even if that's the case, it doesn't explain this particular failure. And for what it's worth, the split was on the top of the hose, not the bottom, so a theory that the hose was damaged by road debris prior to the failure is simply not valid.
