Step Cover Problem

Duff Norton Mod. #LM100-1-150 on mine.

Interior Step Cover Actuator

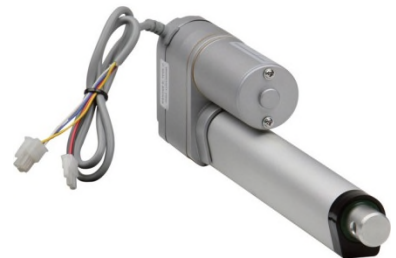
Mine came apart and stripped threads out. Newmar has them (pricey) tried salvage yards with no luck. a salvage yard man told me to get the extended and retracted measurements. do an internet search for 12 volt actuator, he said that the import work as good as the Newmar. I did this last year and it worked for me. Can't remember the cost, it was less than a \$100.00 w/freight. Not that tuff to install, a little frustrating but not bad.

Duff - Norton does not sell to public, newmar sells for 300.00 plus shipping go to www.firgelliauto.com 129.00 plus shipping. same moter just better.

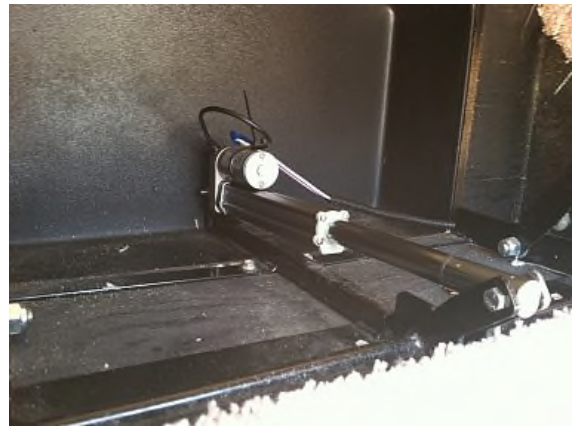
A Photo of the step linear actuator installed

Here is a photo of the installed step [actuator](#) with the step in the full "upright and locked"

position 😊 You can see most of the detail of the install which is trivial. Cost at drillspot was about \$200.00. Sorry it took so long to load the picture.... but my honey do list is about as long

Installed the LT150. installation was easy. Works perfectly and I can stand on it (170 lbs). The secret is to raise the step until the side braces (under the step) go over center which provides the locking function. Hold the button, until the step raises up slightly above floor level and settles backdown. the side mechanism is in full lock. The Dunn Norton LT100-1-150 seems to have the right amount of throw to do this. I think the LT100-1-100 mentioned in other posts will be too short and bend/break the push rod.

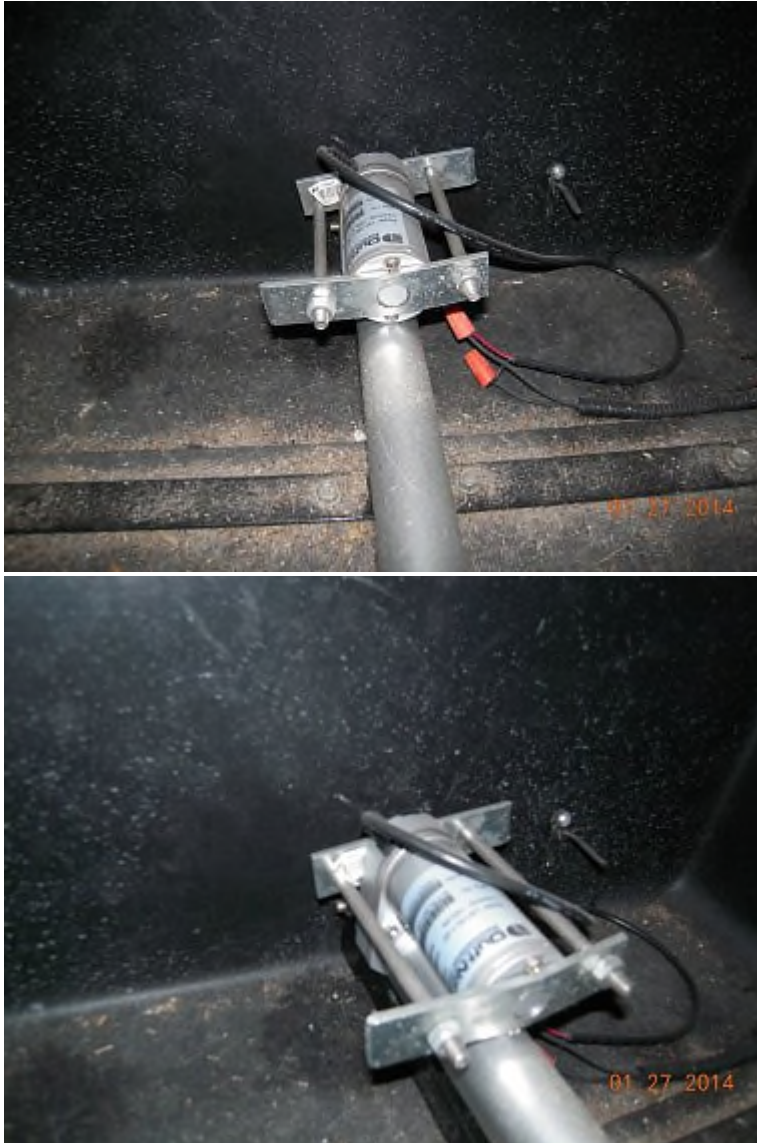
Try this, it's pretty simple. You may want to source better material but when I repaired mine, I went with some odds and ends I have kicking around. Just put a "brace" around the motor and gear box.
